## Windstorm Mitigation Report (OIR-B1-1802)

Chateaumere Condominium Association, Inc.  
Bldg A, 6080 Pelican Bay Blvd, Units 101-104, 201-505  
Naples, FL 34108

As of 08-06-2025 | FPAT File# MUD2525269

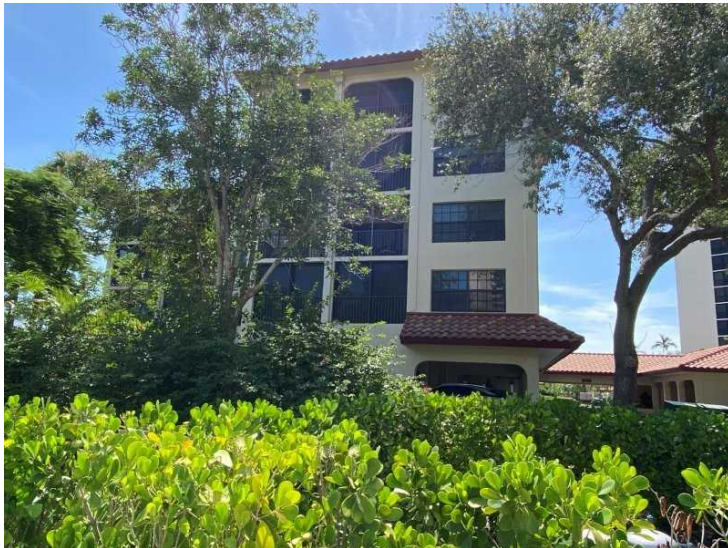
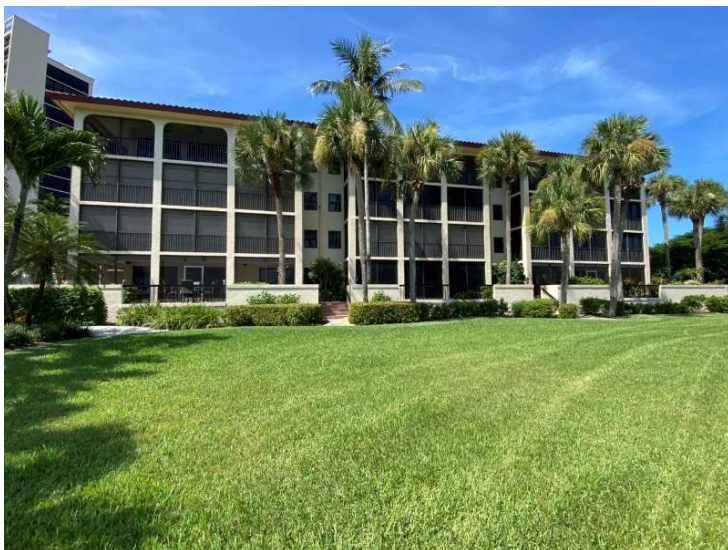
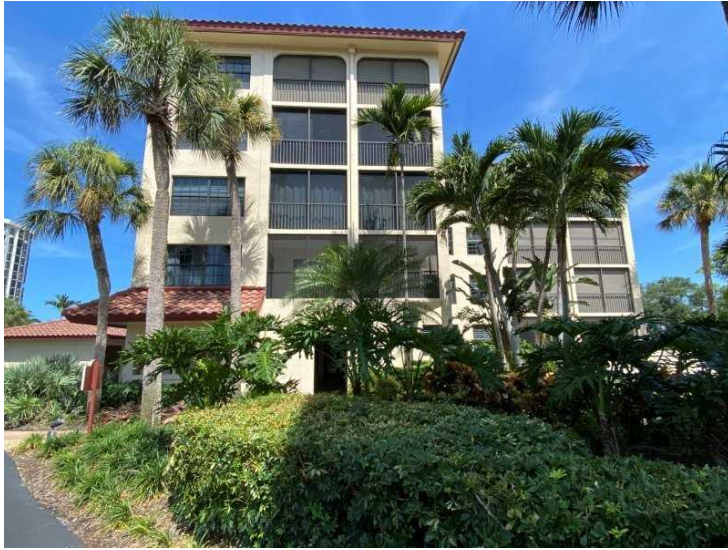
Exterior Elevation

| <b>5. Roof Geometry:</b><br>Comments: | <b>Other Roof</b><br>Inspection revealed a combination of pitched and flat roof areas. The flat roof area accounts for approximately 28% of the total roof area. |

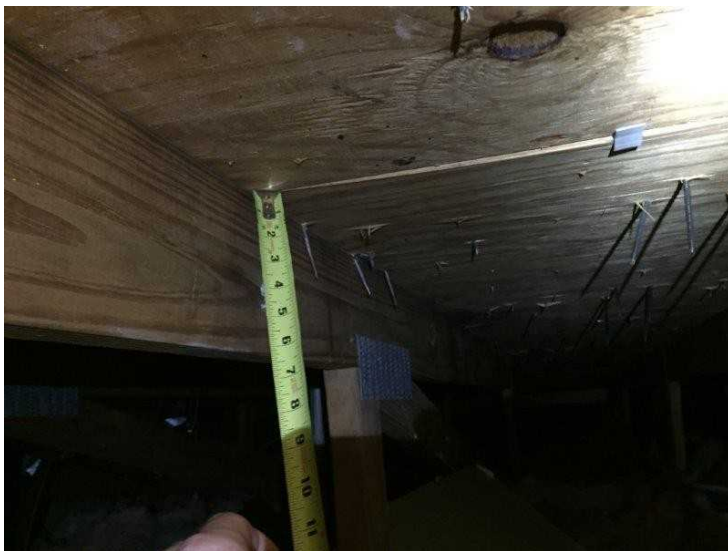
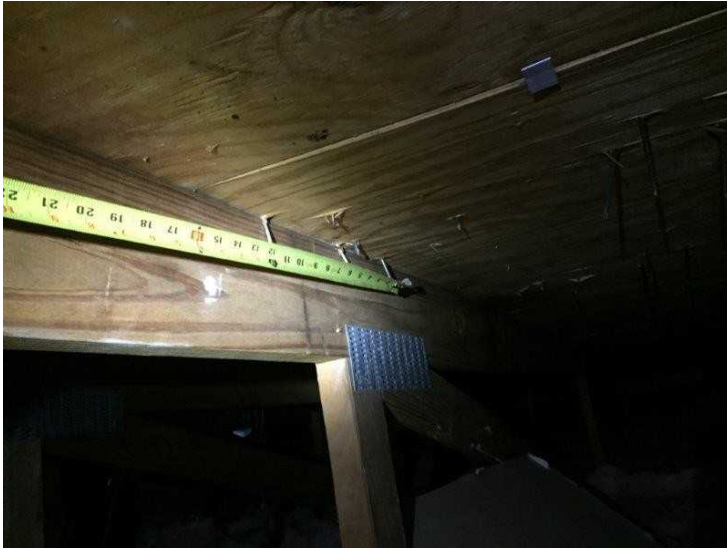
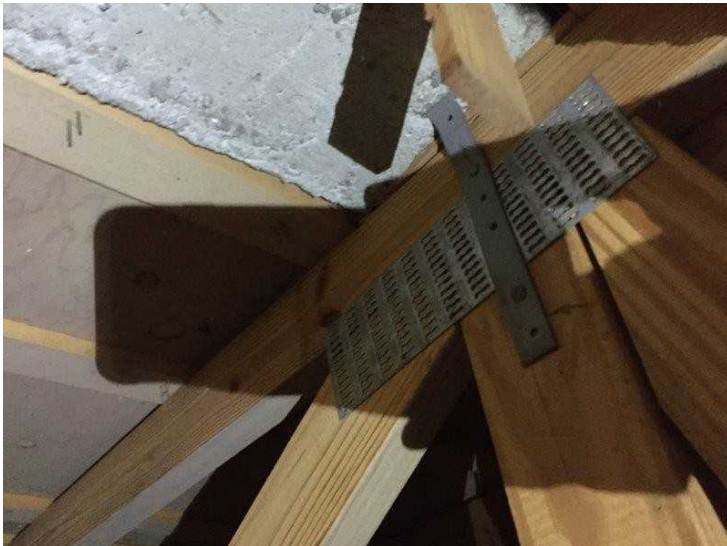
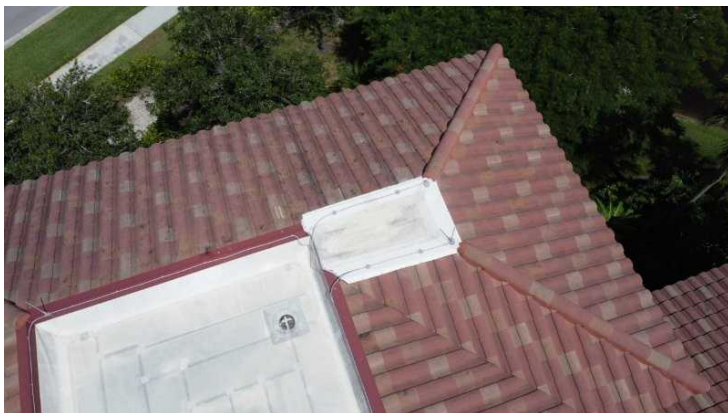
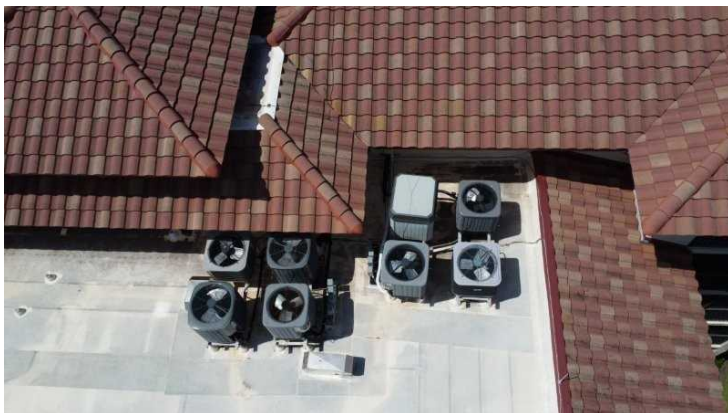
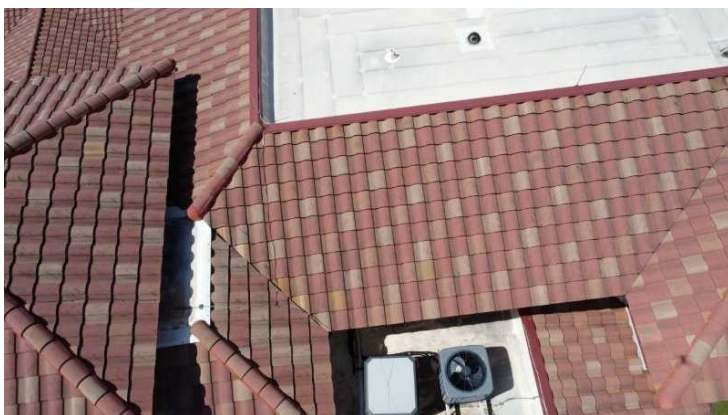
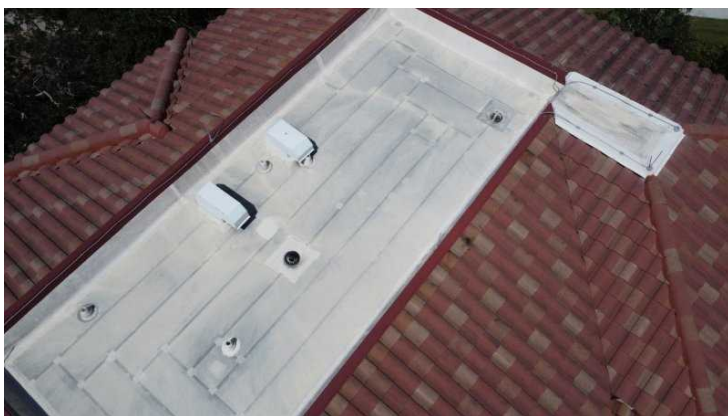
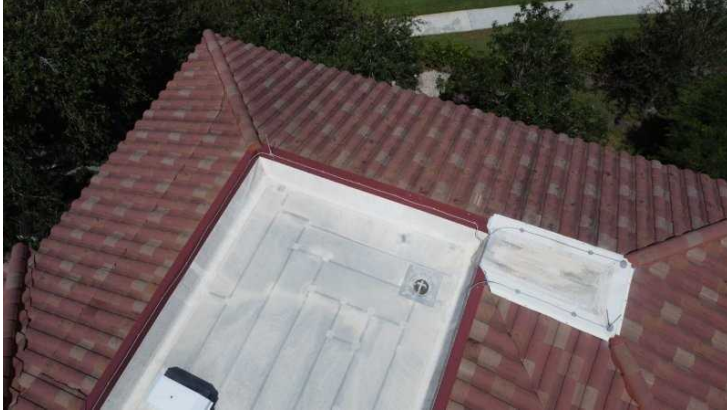
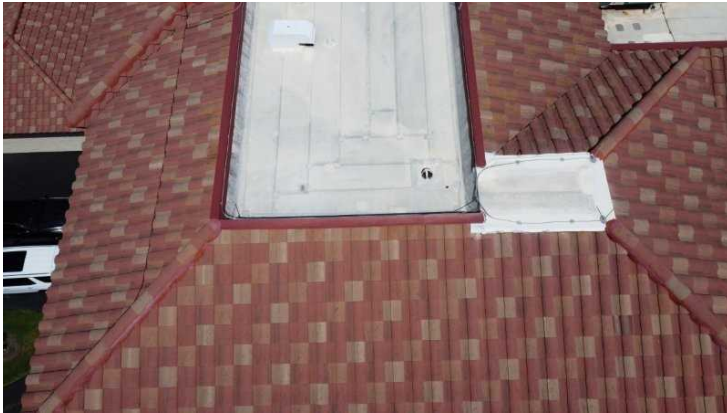
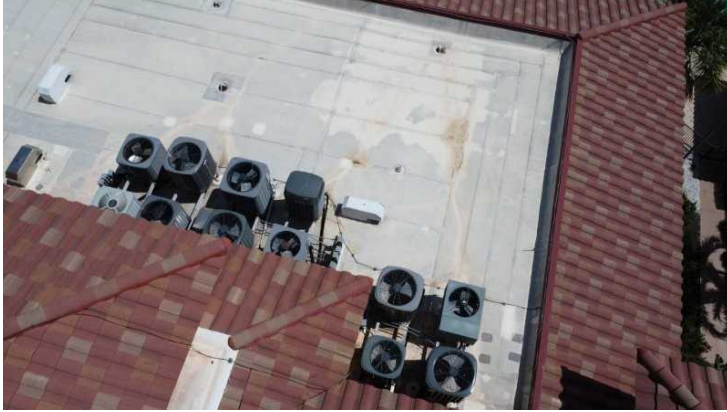
Roof Construction

| <b>3. Roof Deck Attachment:</b><br>Comments: | <b>Level B</b><br>Inspection verified 1/2" plywood roof deck attached with 8d nails at a minimum of 6" on the edge & 12" in the field. |
| <b>4. Roof to Wall Attachment:</b><br>Comments: | <b>Toe Nails</b><br>Inspection verified embedded straps fastened with less than three nails. |

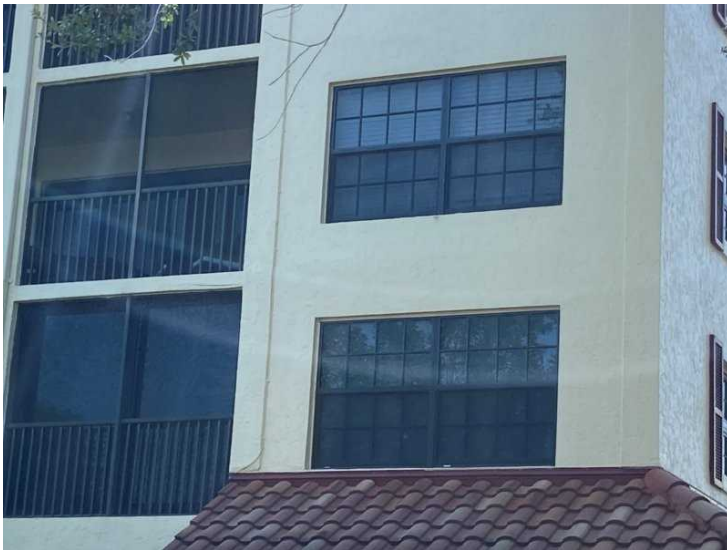
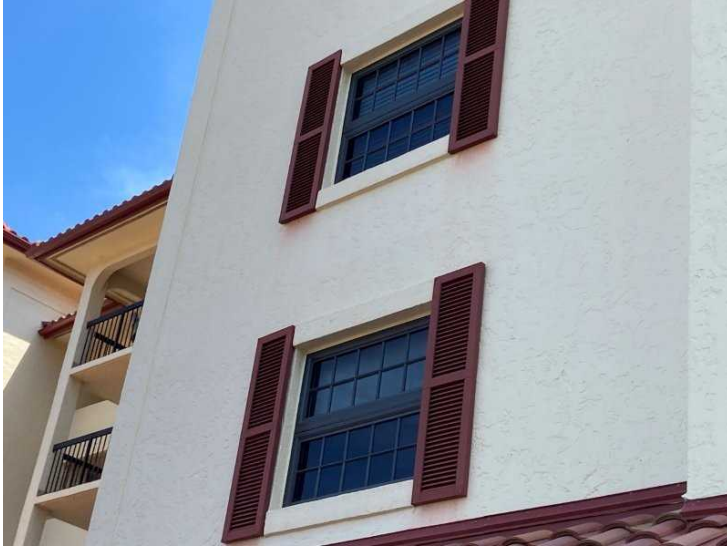
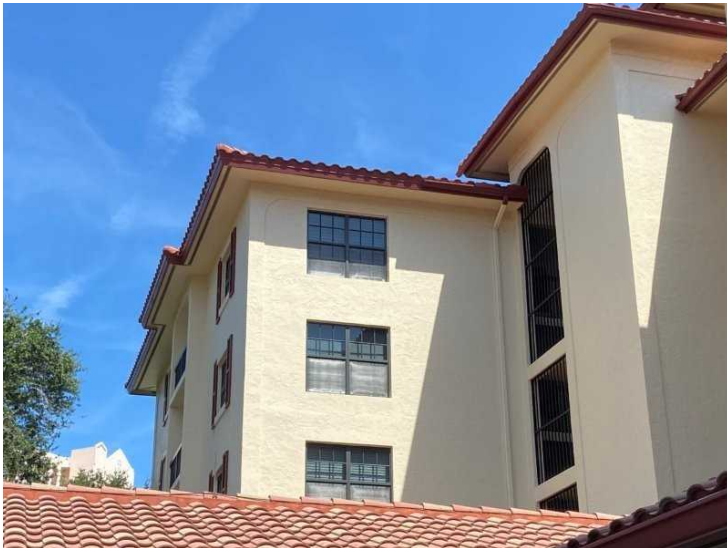
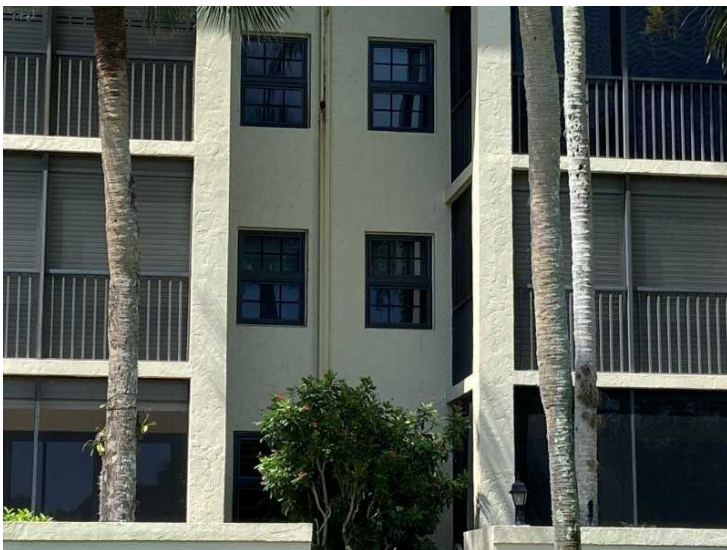
Opening Protection

| <b>7. Opening Protection:</b><br>Comments: | <b>Exterior Openings Cyclic Pressure &amp; 9-lb Large Missile</b><br>Inspection verified all glazed openings are protected with Large Missile Impact rated windows and sliding glass doors. The entry doors are of original construction with no impact testing specifications. |
