## Windstorm Mitigation Report (OIR-B1-1802)

Chateaumere Condominium Association, Inc.  
Bldg B, 6060 Pelican Bay Blvd, 101-104, 201-505  
Naples, FL 34108

As of 08-06-2025 | FPAT File# MUD2525269

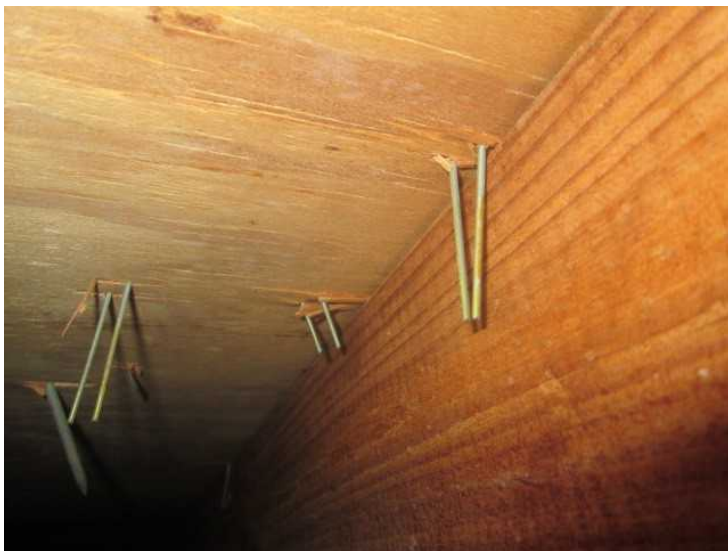
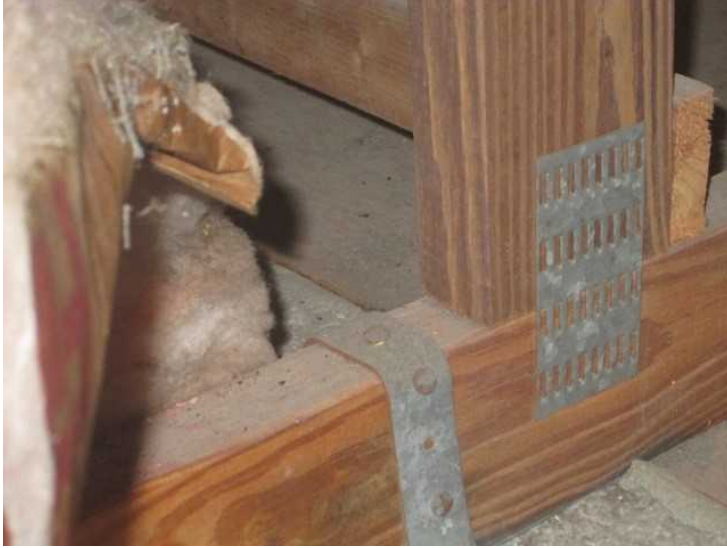
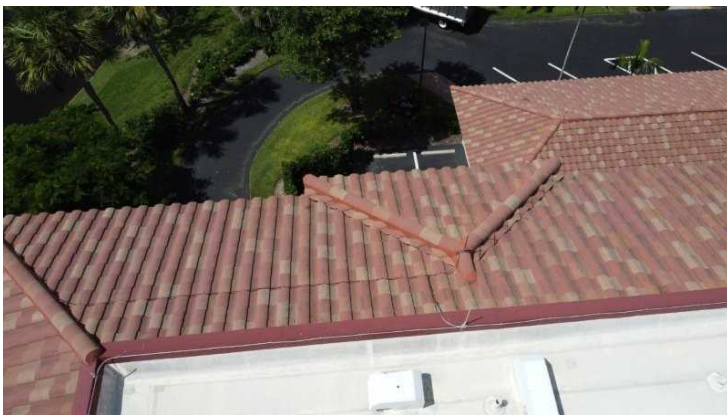
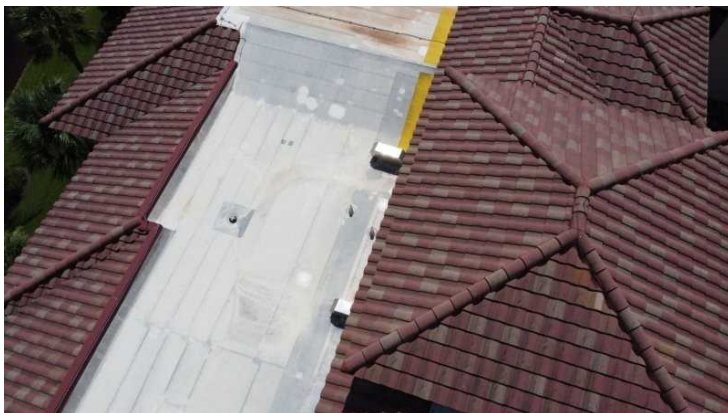
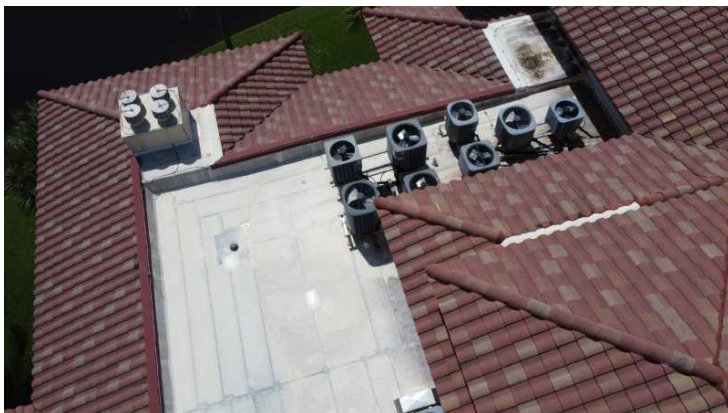
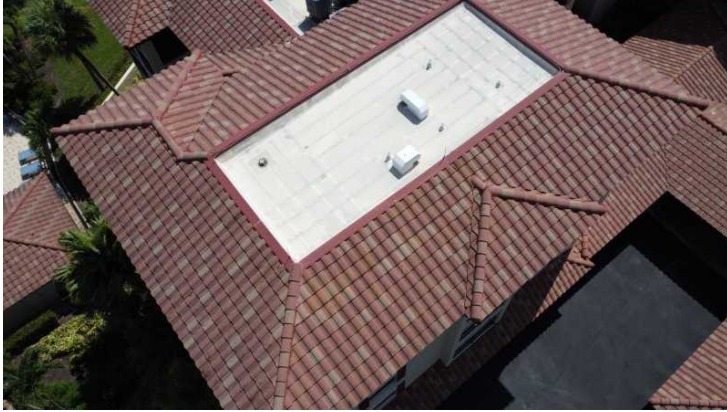
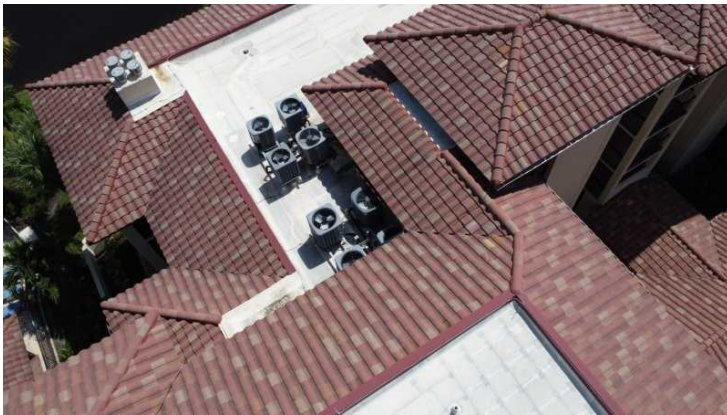
Roof Construction

| <b>3. Roof Deck Attachment:</b><br>Comments: | <b>Level A</b><br>Inspection verified 1/2" plywood roof deck attached with staples at a minimum of 6" on the edge & 12" in the field. |
| <b>4. Roof to Wall Attachment:</b><br>Comments: | <b>Clips</b><br>Inspection verified embedded straps fastened with a minimum of three nails. |
| <b>5. Roof Geometry:</b><br>Comments: | <b>Other Roof</b><br>Inspection revealed a combination of pitched and flat roof areas. The flat roof area accounts for approximately 28% of the total roof area. |
| <b>6. SWR:</b><br>Comments: | <b>No</b><br>Inspection verified no secondary water resistance. |

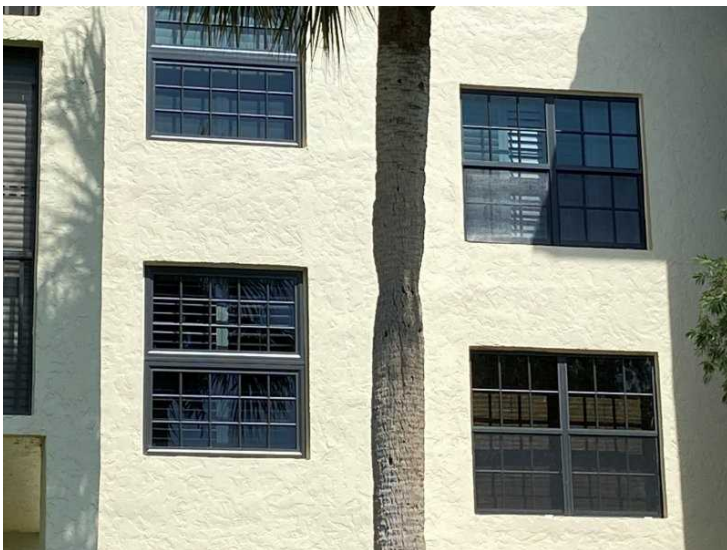
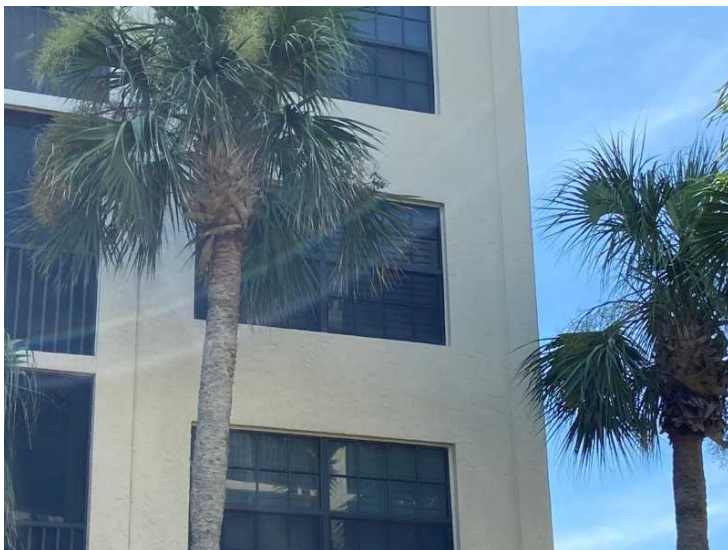
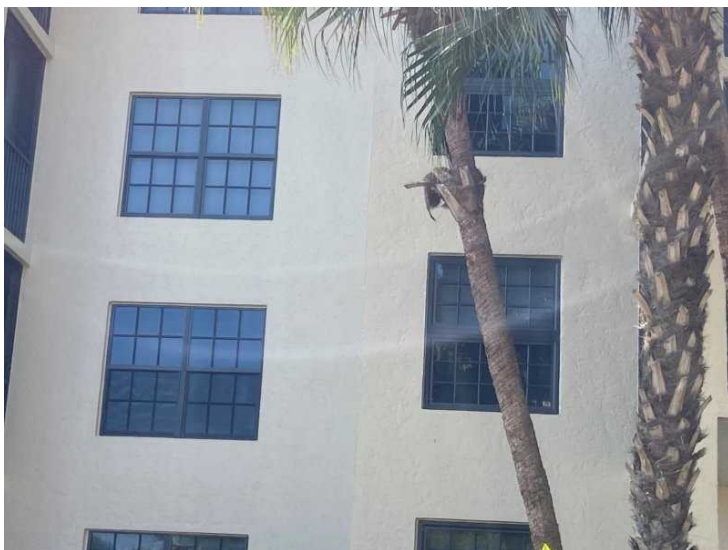
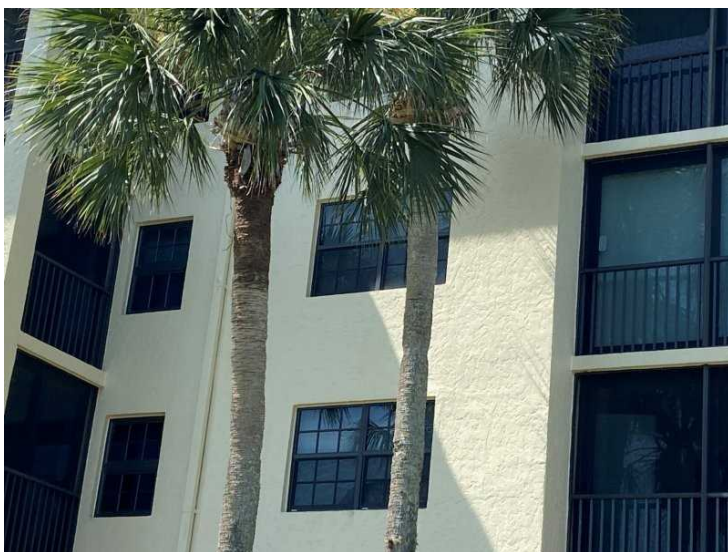
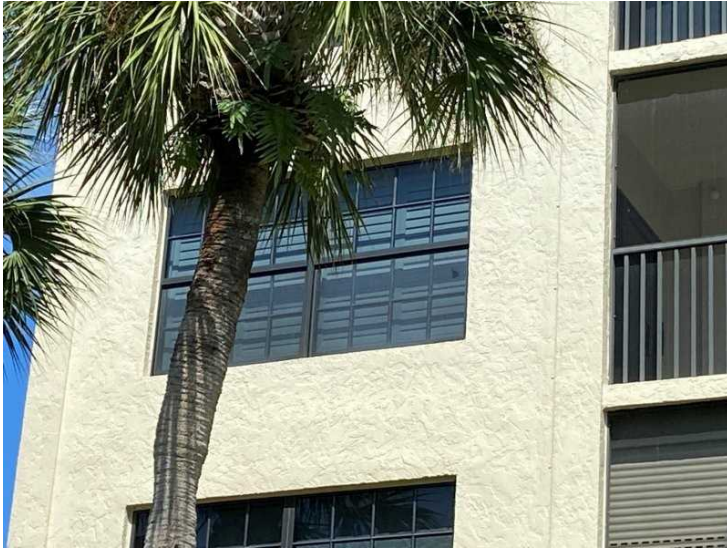
Opening Protection

| <b>7. Opening Protection:</b><br>Comments: | <b>Exterior Openings Cyclic Pressure &amp; 9-lb Large Missile</b><br>Inspection verified all glazed openings are protected with Large Missile Impact rated windows and sliding glass doors. The entry doors are of original construction with no impact testing specifications. |
