## Windstorm Mitigation Report (OIR-B1-1802)

Chateaumere Condominium Association, Inc.

Bldg C, 6000 Pelican Bay Blvd, Units 101-1504, PH1-PH4

As of 08-06-2025 | FPAT File# MUD2525269

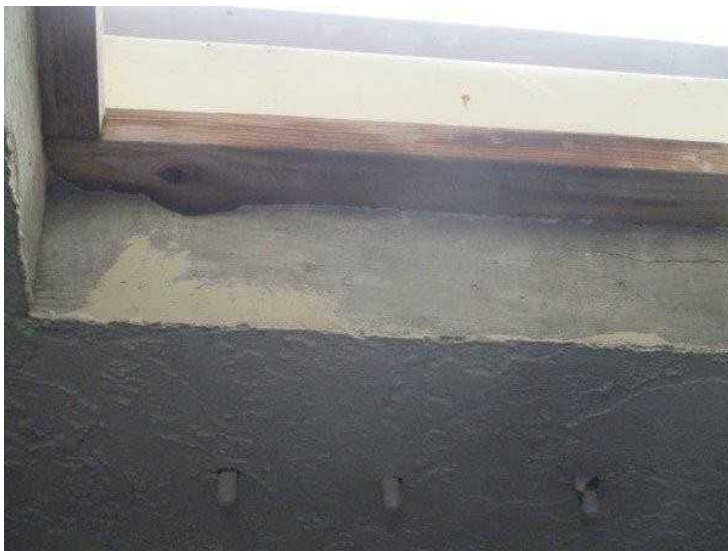
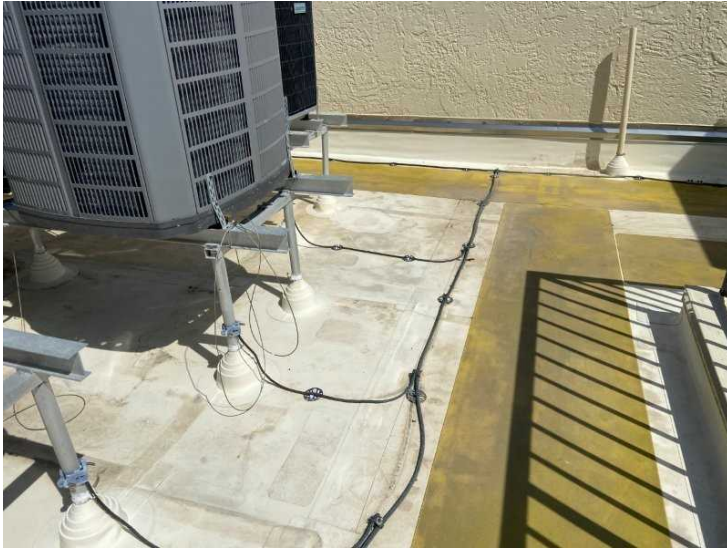
Roof Construction

| <b>3. Roof Deck Attachment:</b><br>Comments: | <b>Reinforced Concrete Roof Deck</b><br>Inspection verified a roof structure composed of cast-in-place or pre-cast structural concrete designed to be self supporting and integrally attached to the wall / support system. |
| <b>4. Roof to Wall Attachment:</b><br>Comments: | <b>Structural</b><br>Inspection verified a roof structure composed of cast-in-place or pre-cast structural concrete designed to be self supporting and integrally attached to the wall / support system. |
| <b>5. Roof Geometry:</b><br>Comments: | <b>Other Roof</b><br>Inspection verified approximately 50% hip and 50% flat roof shapes. |

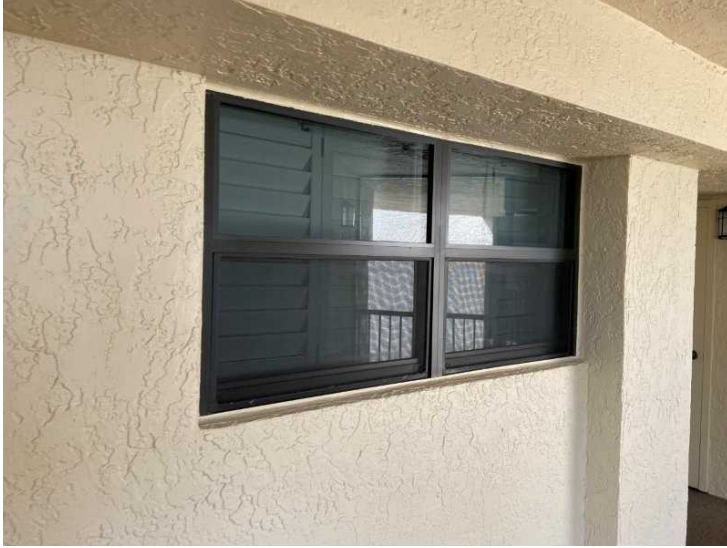
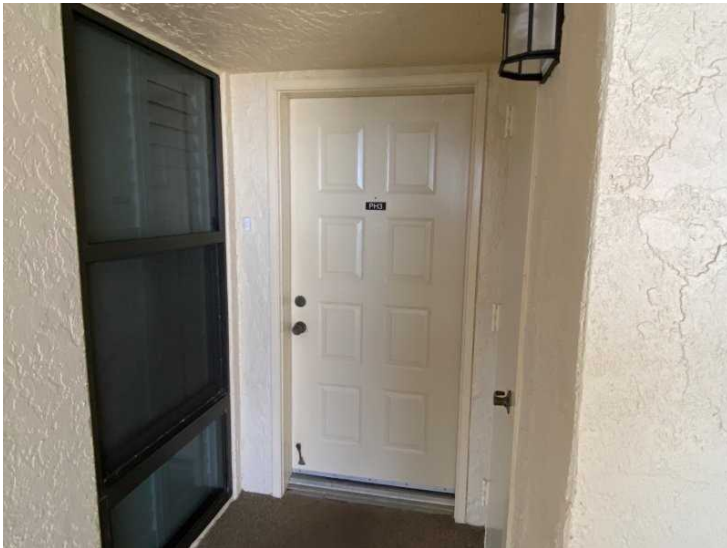
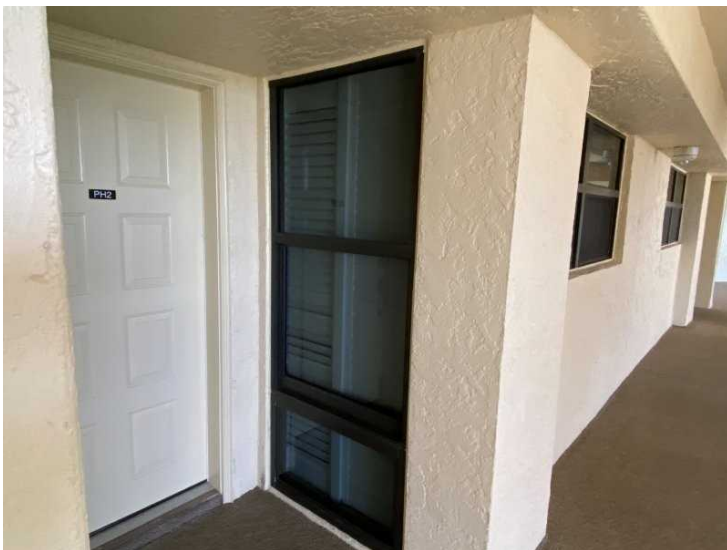
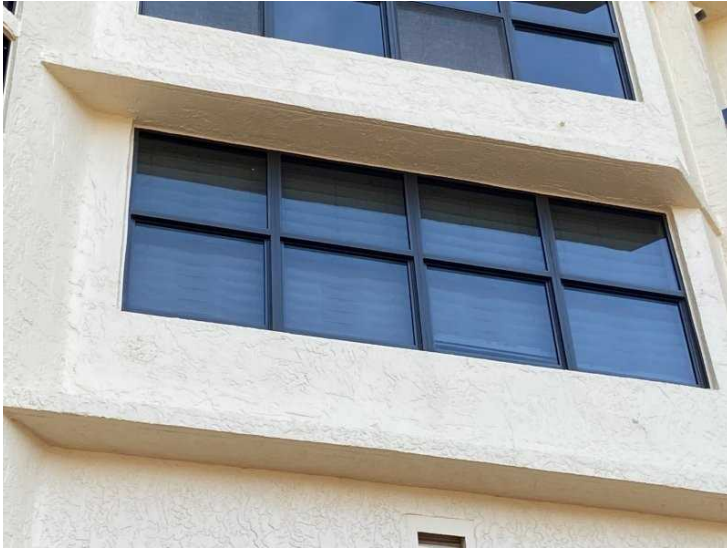
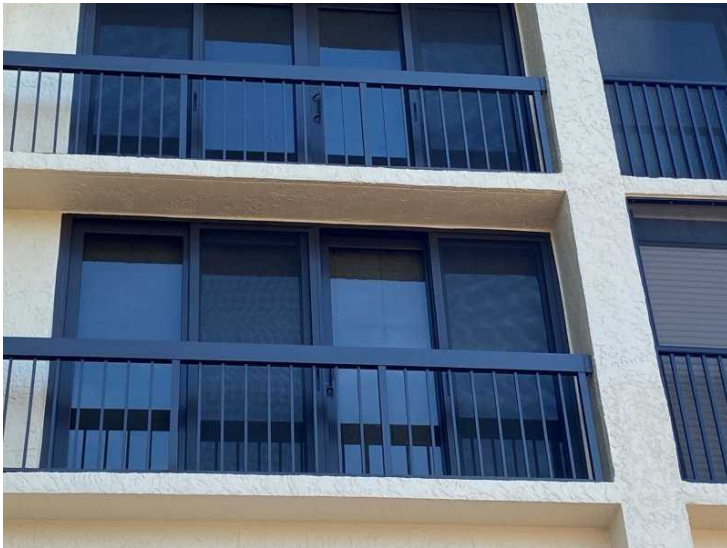
Opening Protection

| <b>7. Opening Protection:</b><br>Comments: | <b>Exterior Openings Cyclic Pressure &amp; 9-lb Large Missile</b><br>Inspection verified all glazed openings are protected with Large Missile Impact rated windows and sliding glass doors. The entry doors are of original construction with no impact testing specifications. |
