## Windstorm Mitigation Report (OIR-B1-1802)

Chateaumere Condominium Association, Inc.  
Bldg D, 6040 Pelican Bay Blvd, Units 101-405  
Naples, FL 34108

As of 08-06-2025 | FPAT File# MUD2525269

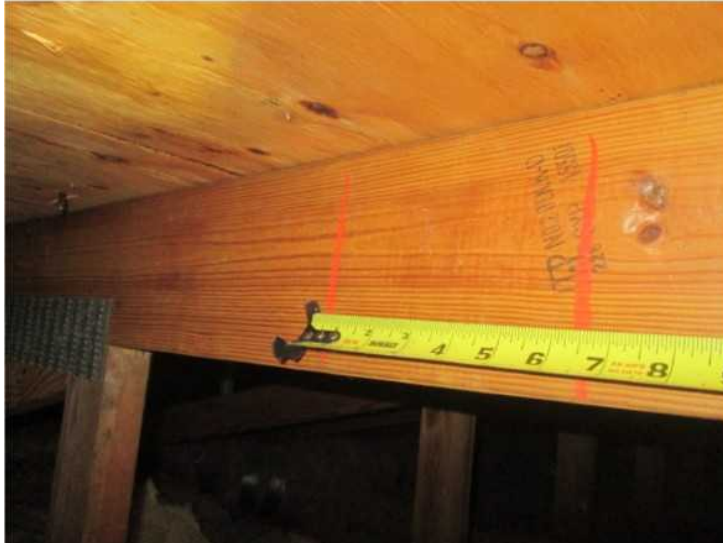
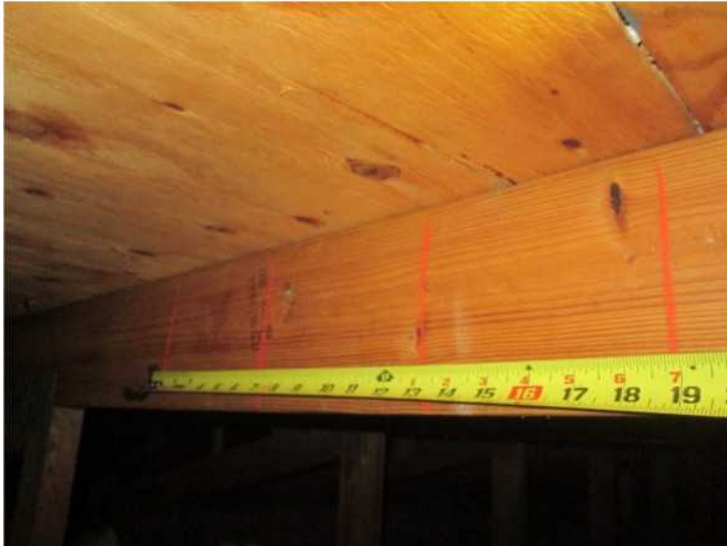
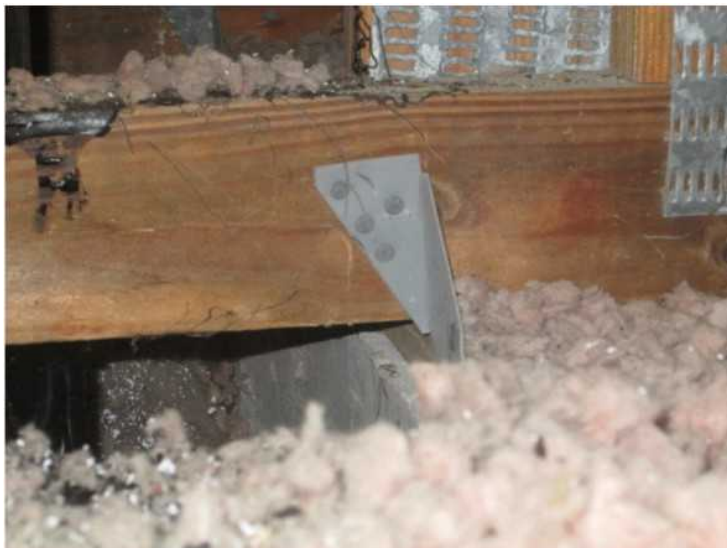
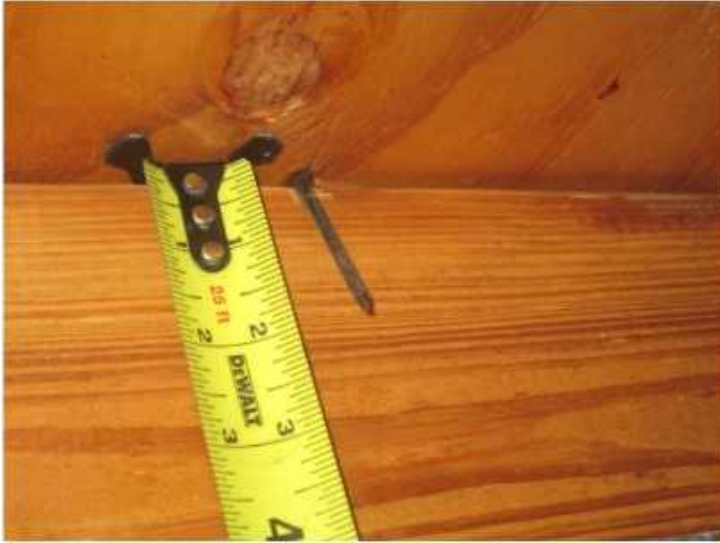
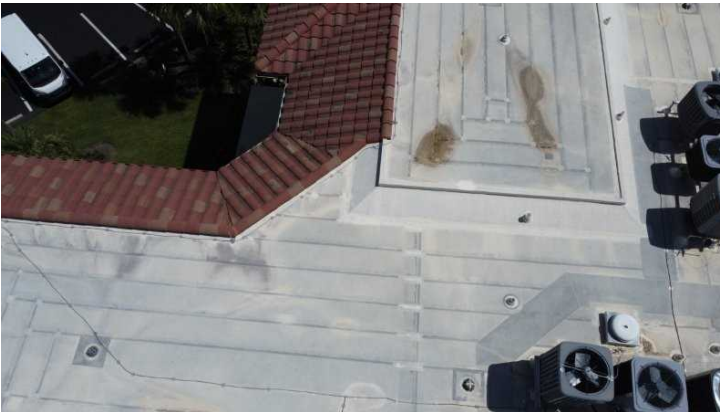
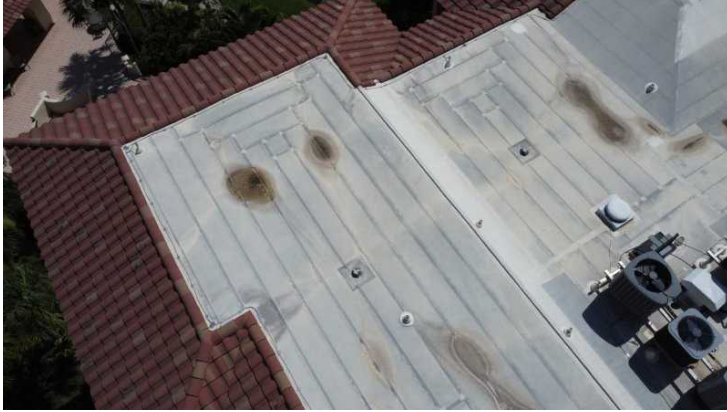
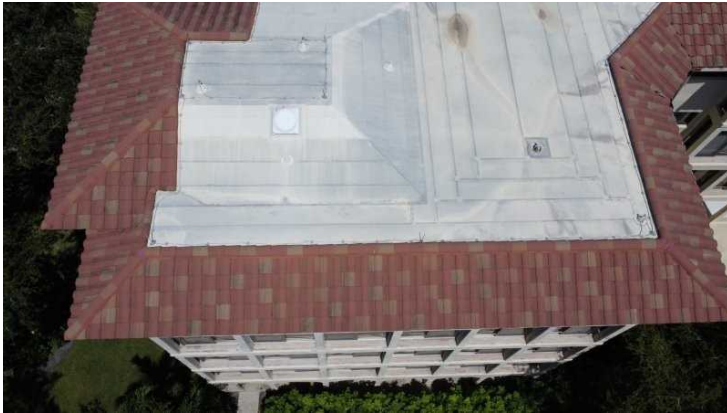
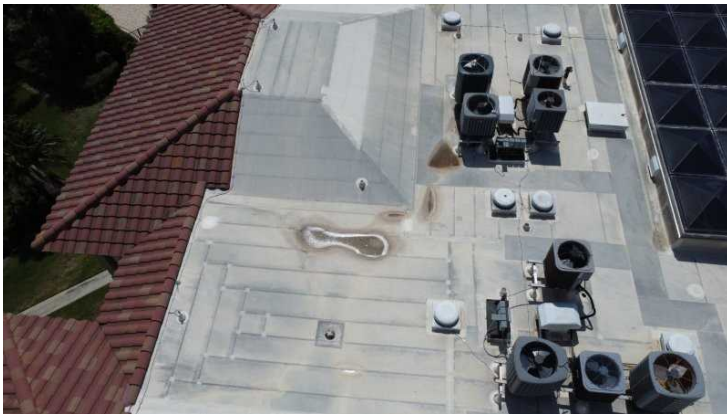
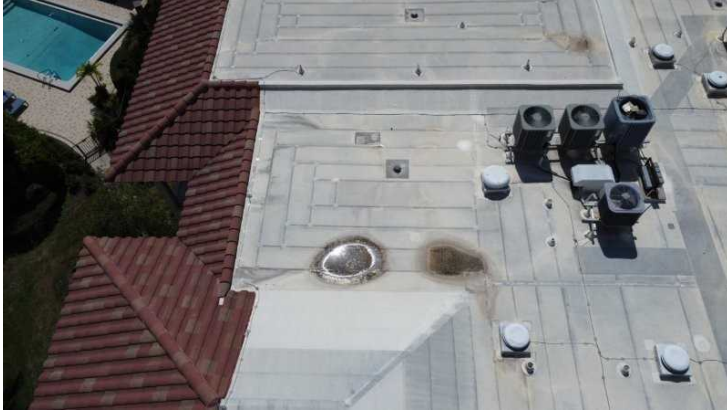
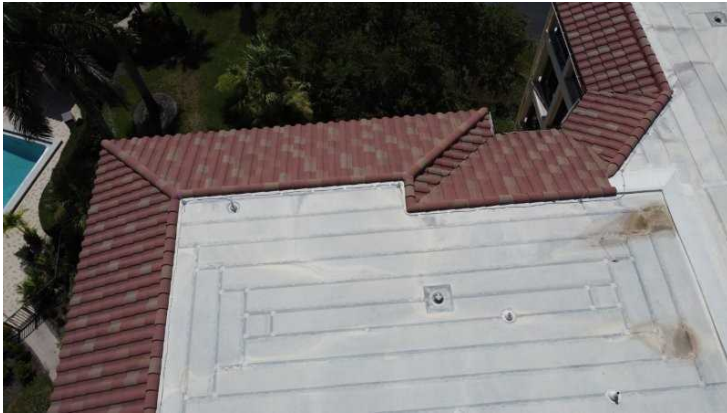
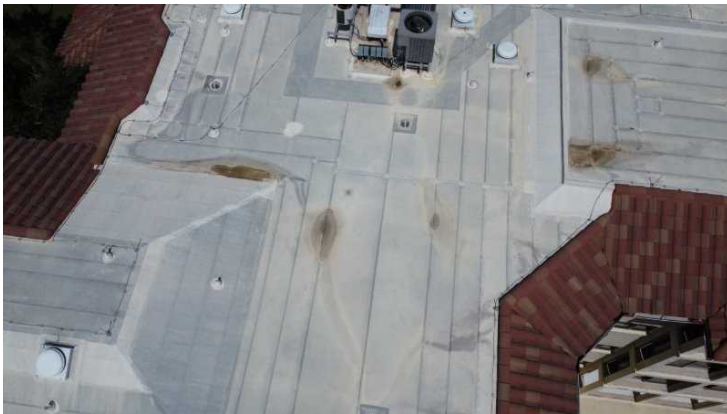
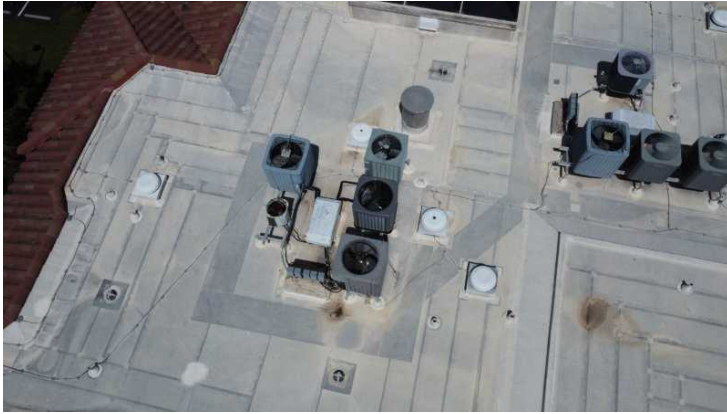
Roof Construction

| <b>3. Roof Deck Attachment:</b><br>Comments: | <b>Level C</b><br>Inspection verified 1/2" plywood roof deck attached with 8d nails at a minimum 6" on the edge & 6" in the field. |
| <b>4. Roof to Wall Attachment:</b><br>Comments: | <b>Clips</b><br>Inspection verified hurricane clips fastened with a minimum of three nails. |
| <b>5. Roof Geometry:</b><br>Comments: | <b>Other Roof</b><br>Inspection revealed a combination of pitched and flat roof areas. The flat roof area accounts for approximately 64% of the total roof area. |
| <b>6. SWR:</b><br>Comments: | <b>No</b><br>Inspection verified no secondary water resistance. |

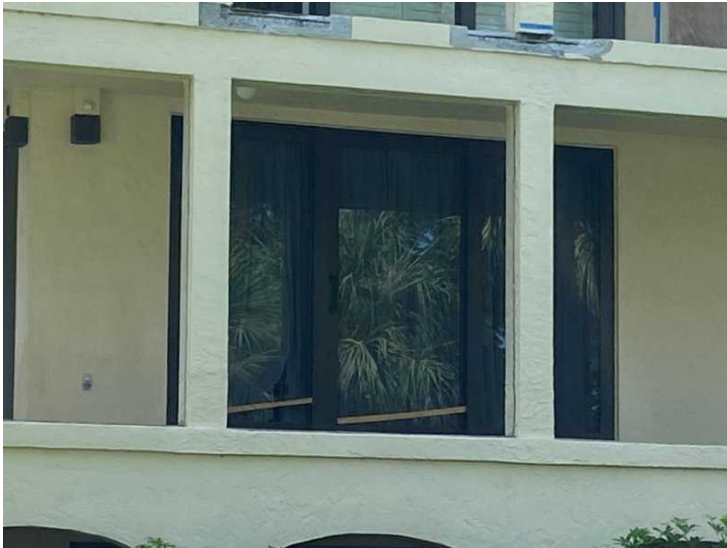
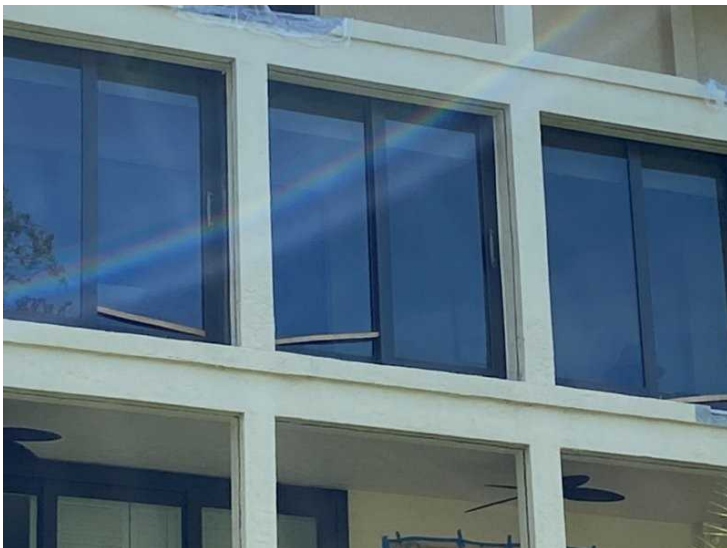
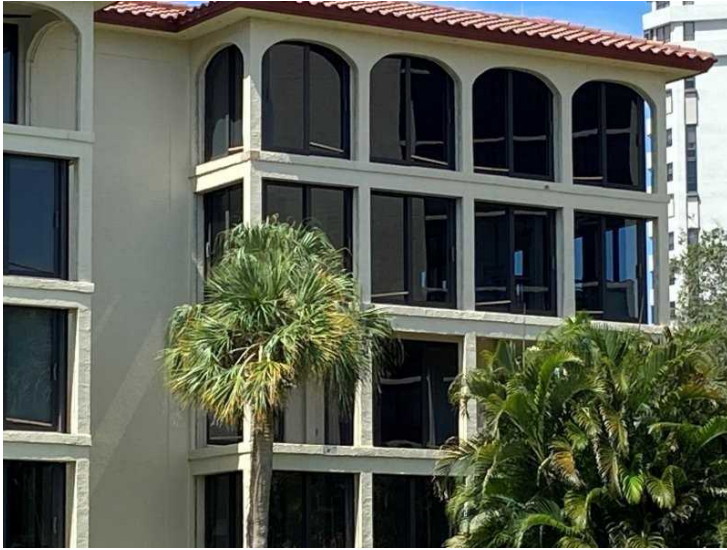
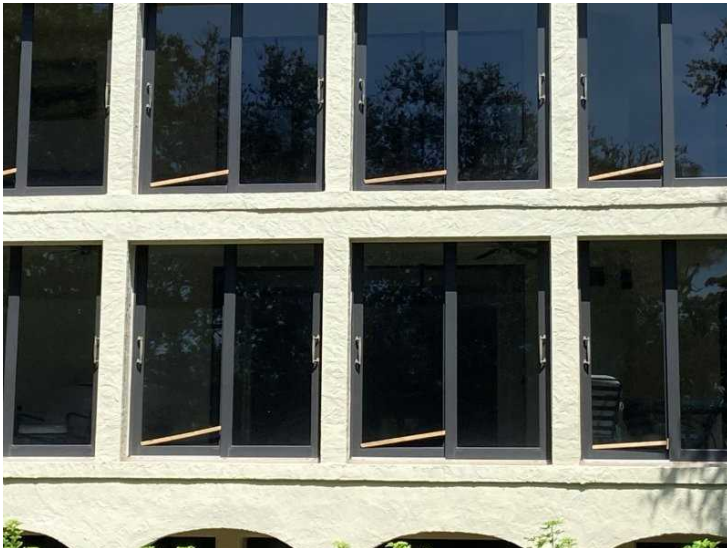
Opening Protection

| <b>7. Opening Protection:</b><br>Comments: | <b>Exterior Openings Cyclic Pressure &amp; 9-lb Large Missile</b><br>Inspection verified all glazed openings are protected with Large Missile Impact rated windows and sliding glass doors. The entry doors are of original construction with no impact testing specifications. |
