## Windstorm Mitigation Report (OIR-B1-1802)

Chateaumere Condominium Association, Inc.  
Bldg E, 6020 Pelican Bay Blvd, Units 101-405  
Naples, FL 34108

As of 08-06-2025 | FPAT File# MUD2525269

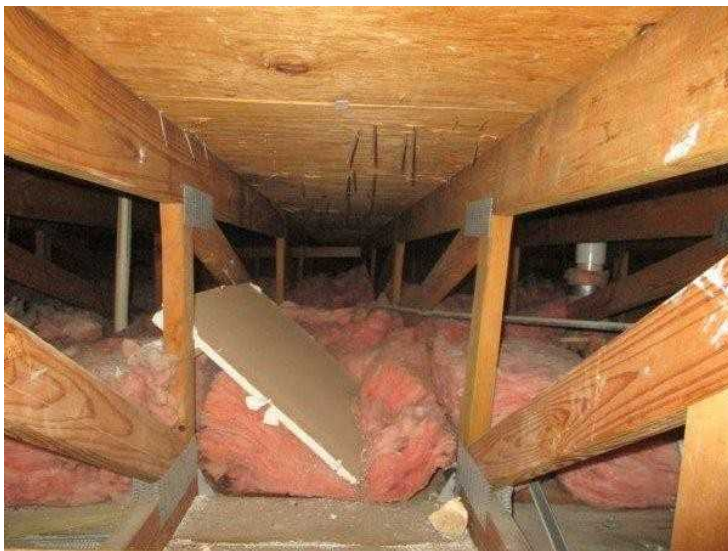
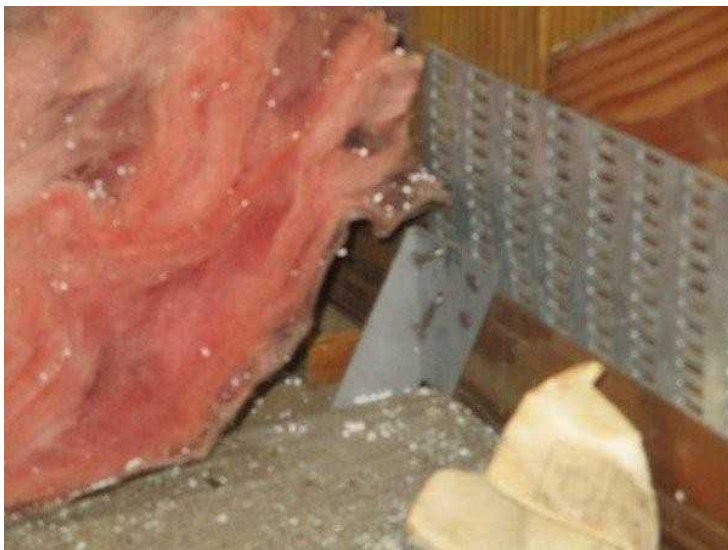
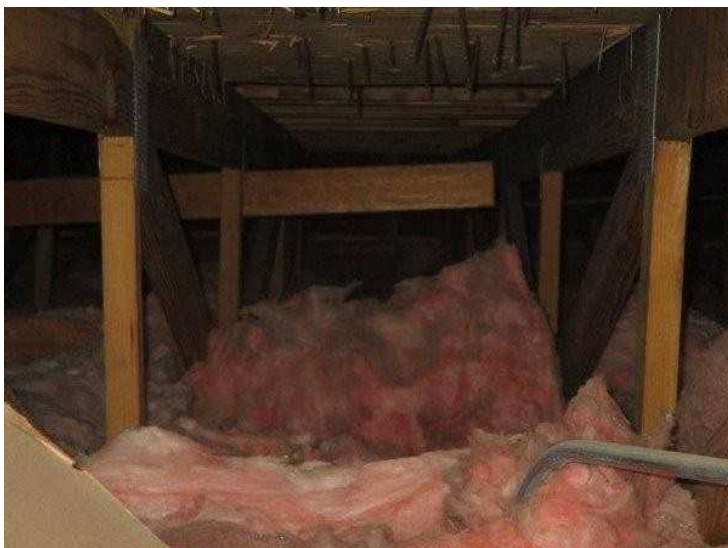
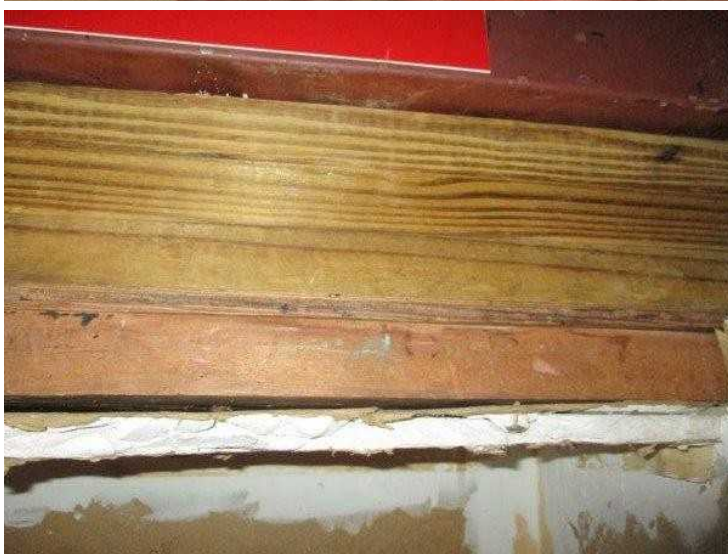
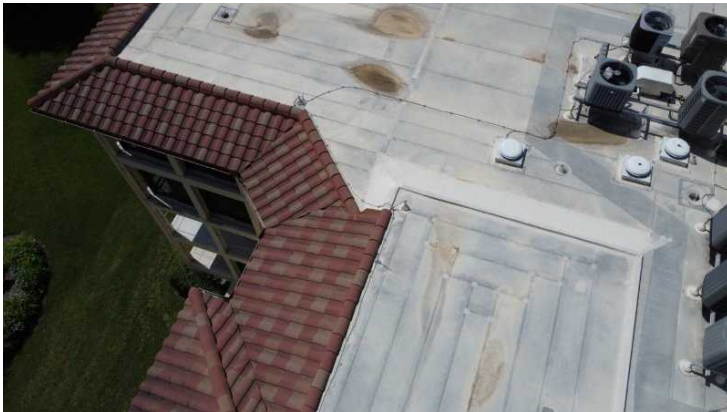
Roof Construction

| <b>3. Roof Deck Attachment:</b><br>Comments: | <b>Level B</b><br>Inspection verified 1/2" plywood roof deck attached with 8d nails at a minimum of 6" on the edge & 12" in the field. |
| <b>4. Roof to Wall Attachment:</b><br>Comments: | <b>Clips</b><br>Inspection verified hurricane clips fastened with a minimum of three nails. |
| <b>5. Roof Geometry:</b><br>Comments: | <b>Other Roof</b><br>Inspection revealed a combination of pitched and flat roof areas. The flat roof area accounts for approximately 64% of the total roof area. |
| <b>6. SWR:</b><br>Comments: | <b>No</b><br>Inspection verified no secondary water resistance. |

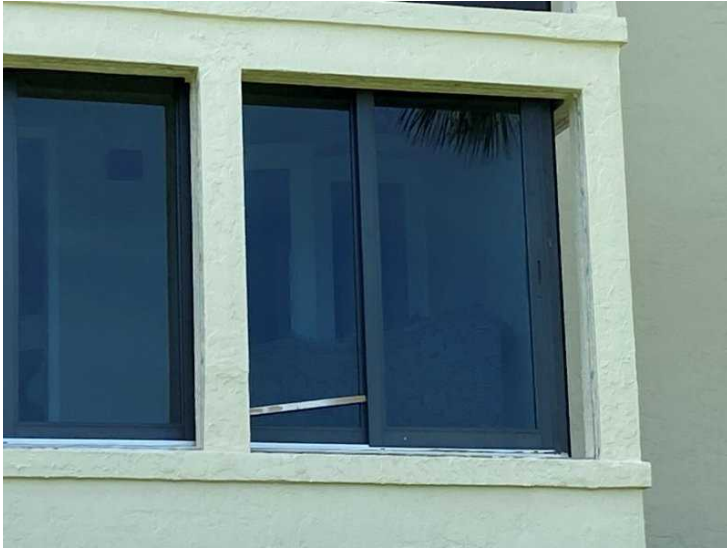
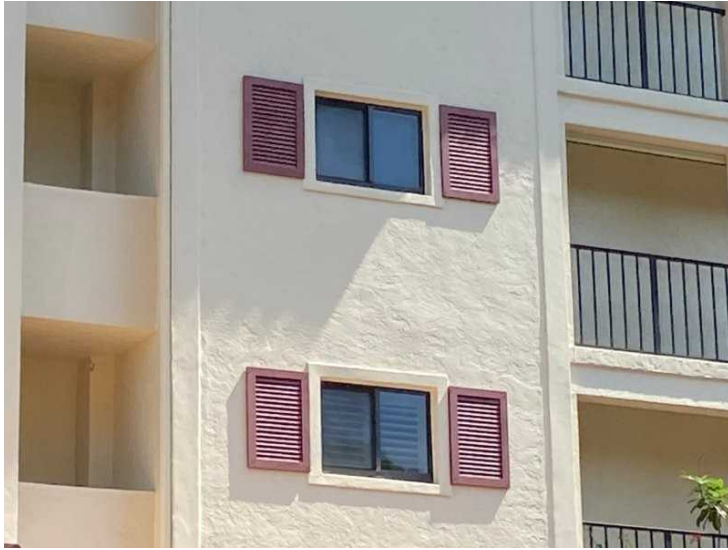
Opening Protection

| <b>7. Opening Protection:</b><br>Comments: | <b>Exterior Openings Cyclic Pressure &amp; 9-lb Large Missile</b><br>Inspection verified all glazed openings are protected with Large Missile Impact rated windows and sliding glass doors. The entry doors are of original construction with no impact testing specifications. |
