COMMERCIAL WINDSTORM MITIGATION REPORT (OIR-B1-1802)

Chateaumere Condominium Association, Inc.
6080 Pelican Bay Blvd, Bldg A, Units 101-104, 201-505
Naples, FL 34108

As of 10/27/2020
FPAT File# MUD2015207

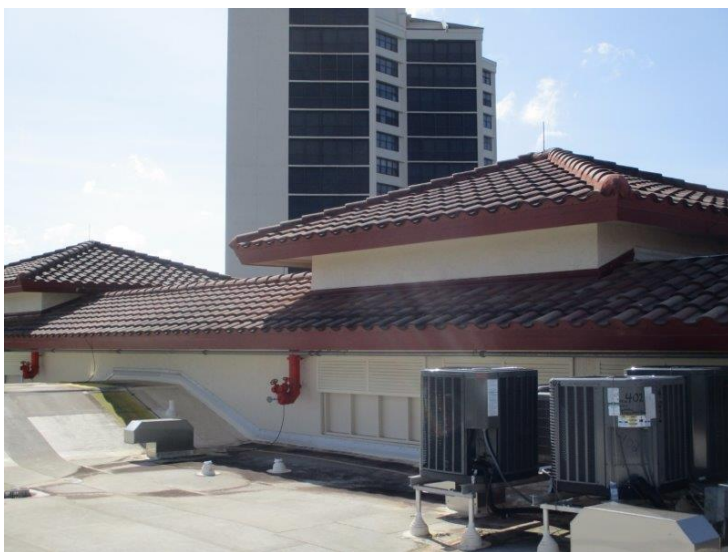
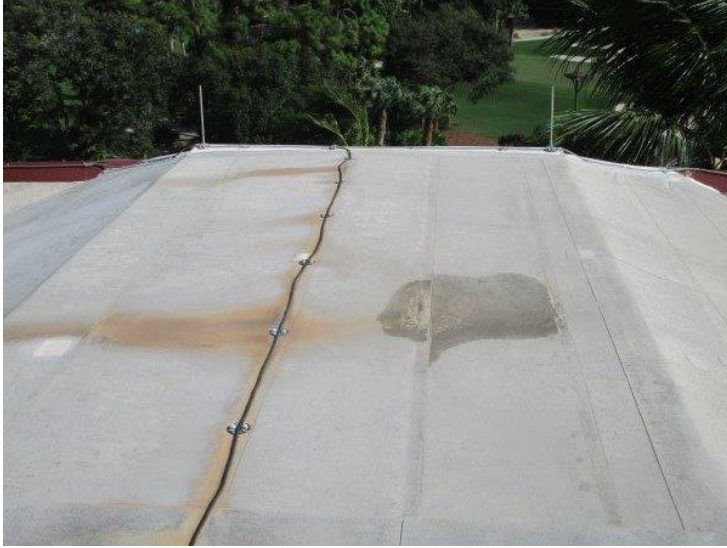
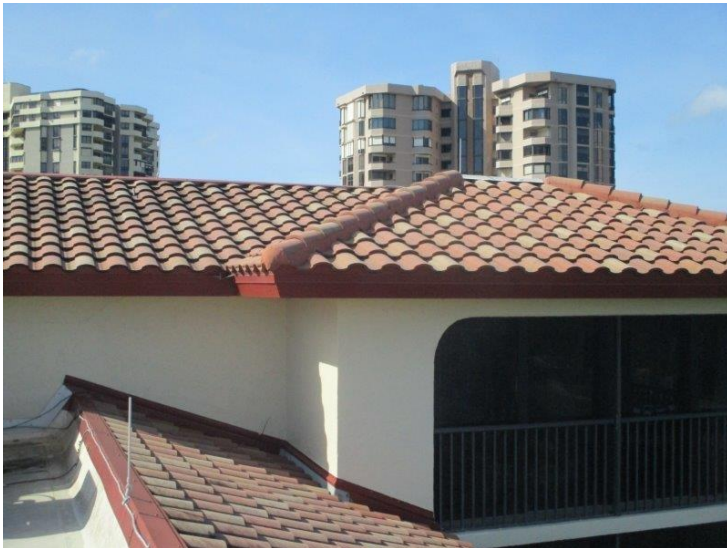
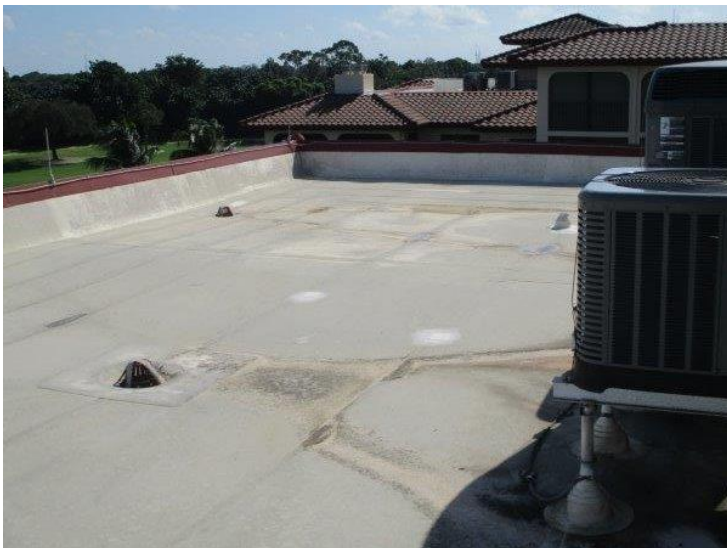
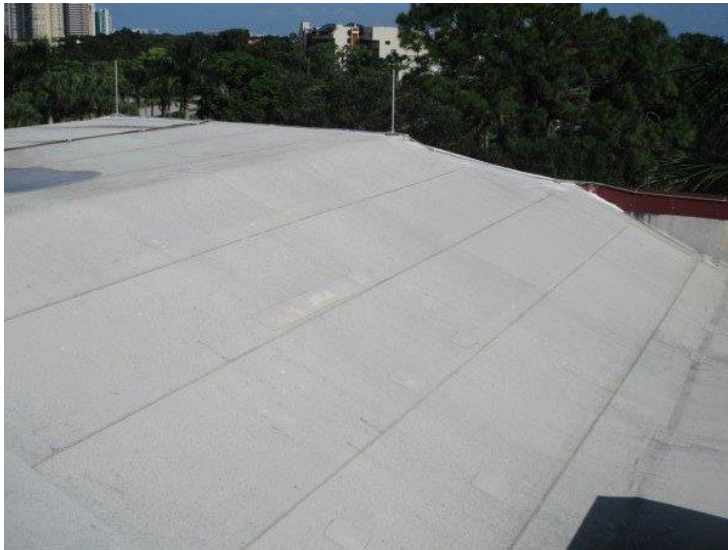
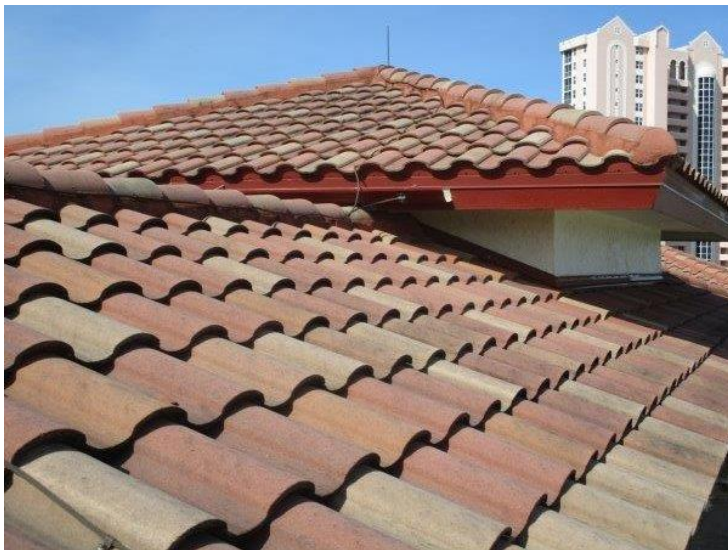
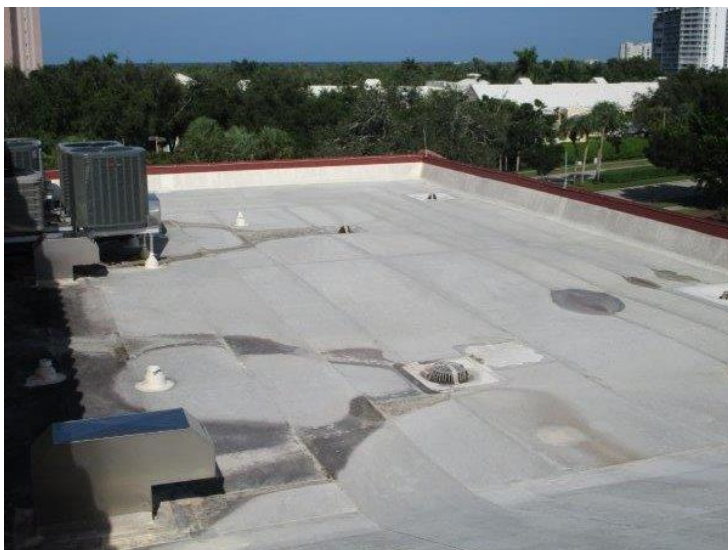
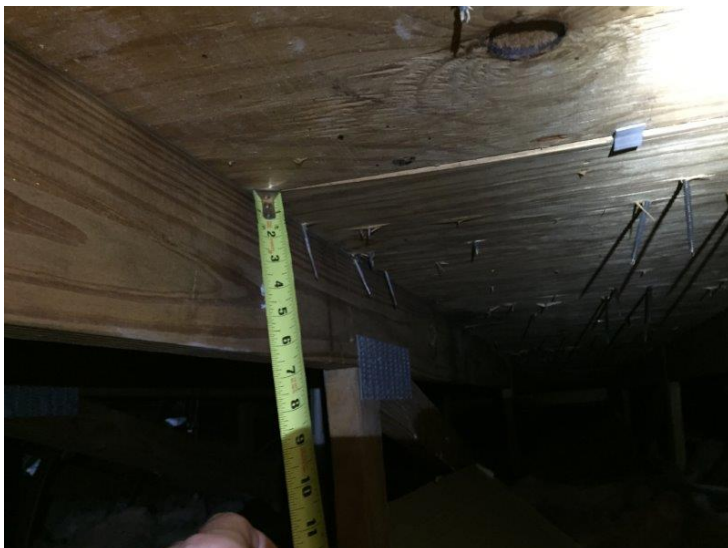
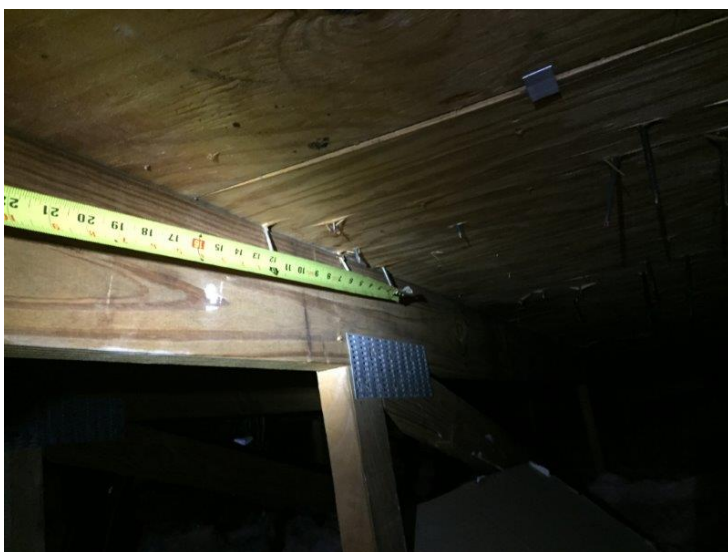
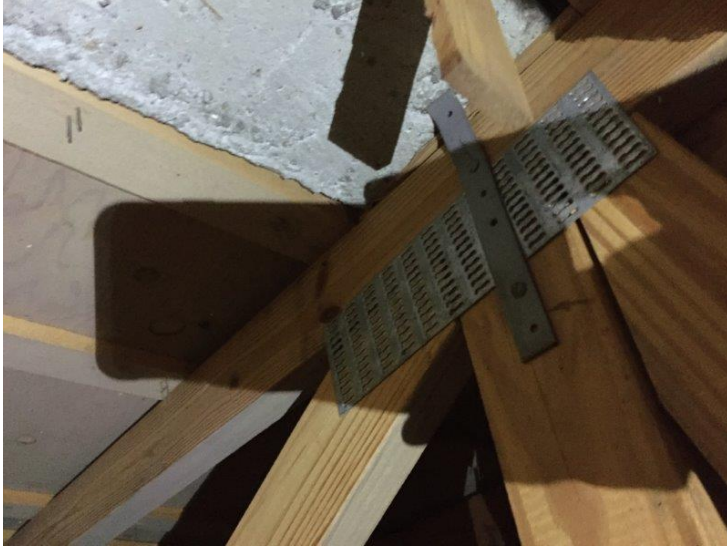
Roof Construction

- 3. Roof Deck Attachment:** **Level B**
Comments: Inspection verified 1/2" plywood roof deck attached with 8d nails at a minimum of 6" on the edge & 12" in the field.

- 4. Roof to Wall Attachment:** **Toe Nails**
Comments: Inspection verified embedded straps fastened with less than three nails.
- 5. Roof Geometry:** **Other Roof**
Comments: Inspection revealed a combination of pitched and flat roof areas. The flat roof area accounts for approximately 28% of the total roof area.
