## COMMERCIAL WINDSTORM MITIGATION REPORT (OIR-B1-1802)

Chateaumere Condominium Association, Inc.

6060 Pelican Bay Blvd, Bldg B, 101-104, 201-505

As of 10/27/2020  
FPAT File# MUD2015207

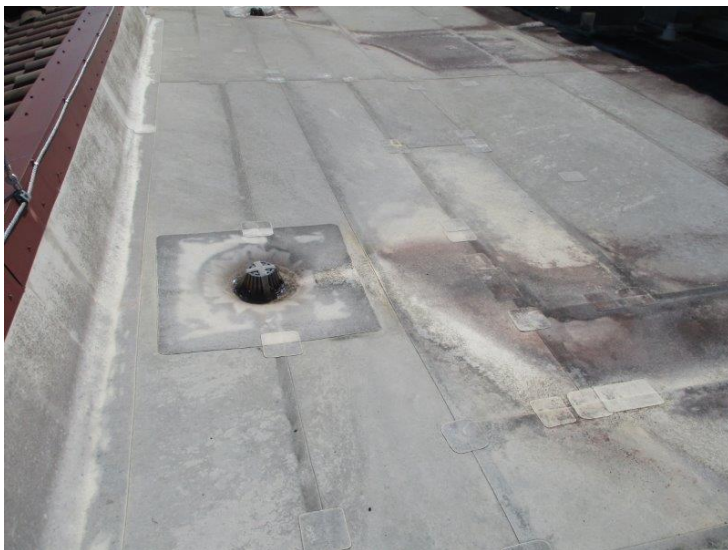
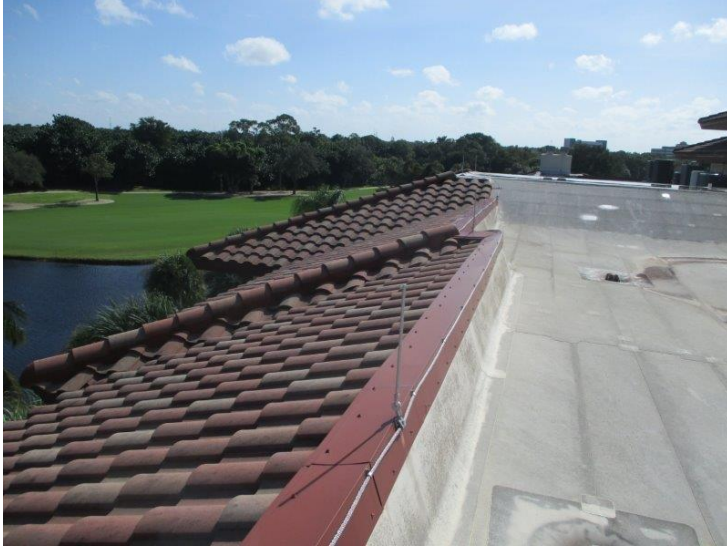
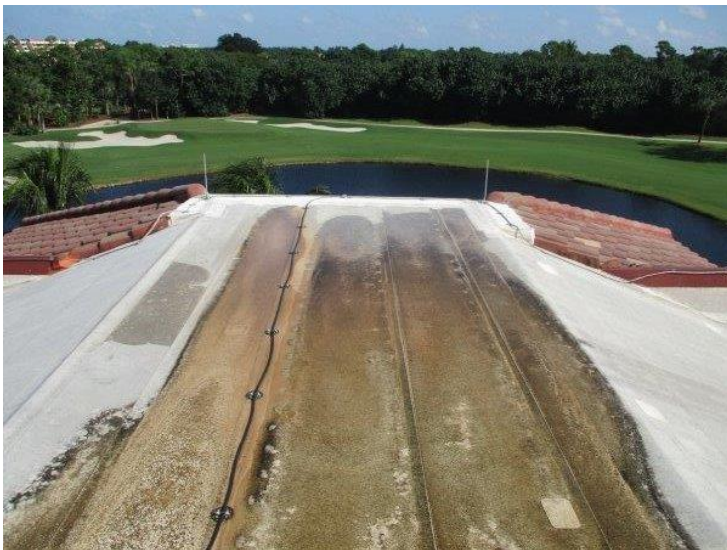
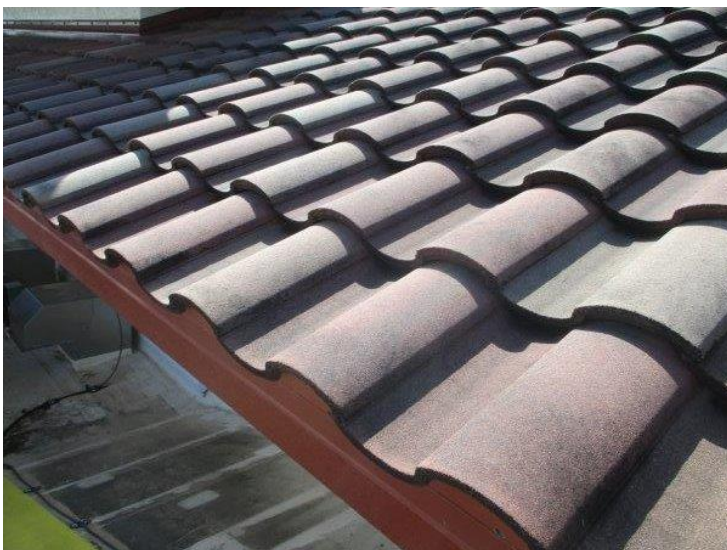
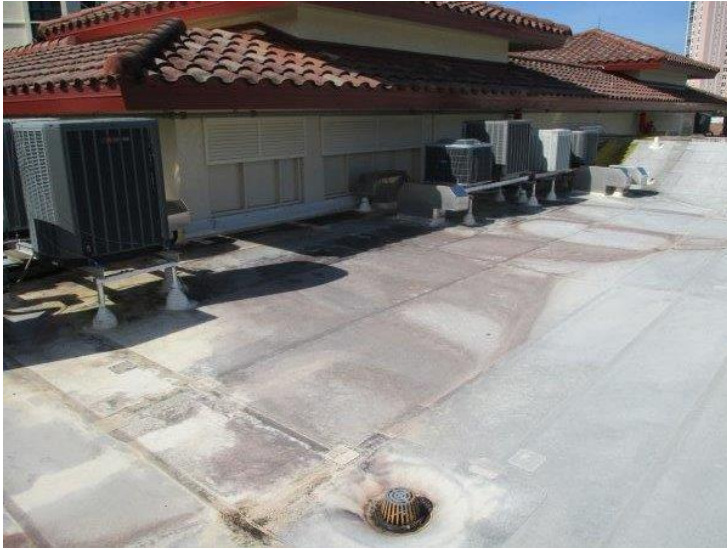
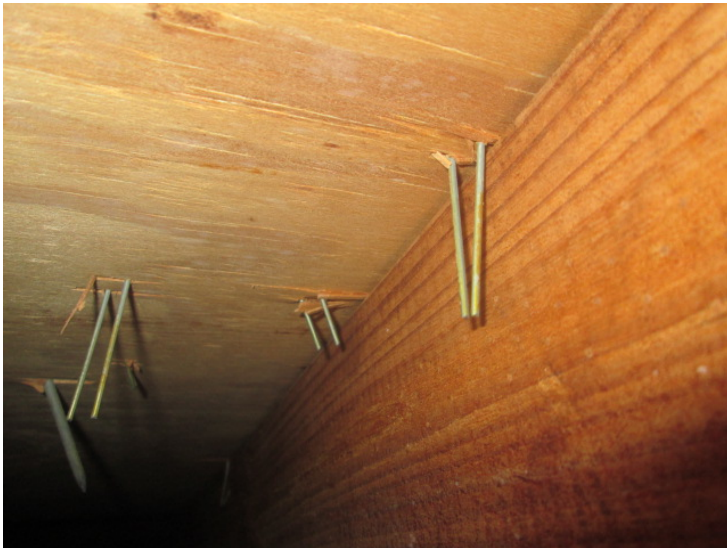
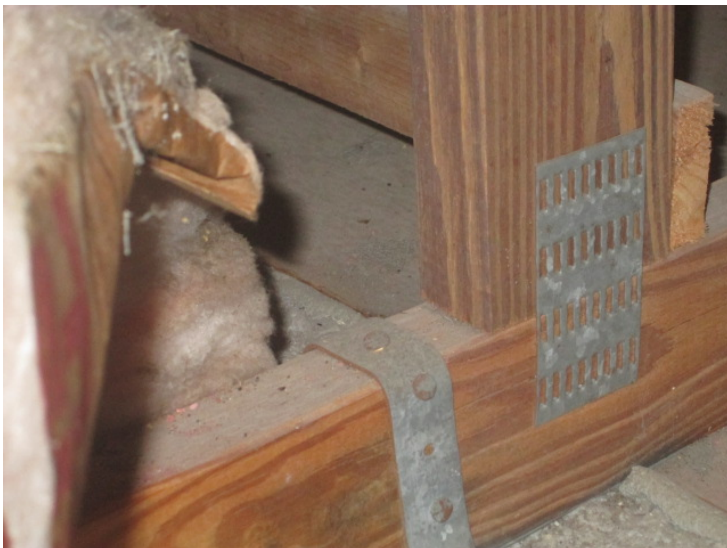
Roof Construction

- 3. Roof Deck Attachment:**        **Level A**  
Comments:                                      Inspection verified 1/2" plywood roof deck attached with staples at a minimum of 6" on the edge & 12" in the field.

- 4. Roof to Wall Attachment:**        **Clips**  
Comments:                                      Inspection verified embedded straps fastened with a minimum of three nails.

- 5. Roof Geometry:**                      **Other Roof**  
Comments:                                      Inspection revealed a combination of pitched and flat roof areas. The flat roof area accounts for approximately 28% of the total roof area.

- 6. SWR:**                                      **No**  
Comments:                                      Inspection verified no secondary water resistance.
