COMMERCIAL WINDSTORM MITIGATION REPORT (OIR-B1-1802)

Chateaumere Condominium Association, Inc.
6000 Pelican Bay Blvd, Bldg C, Units 101-1504, PH1-PH4
Naples, FL 34108

As of 10/27/2020
FPAT File# MUD2015207

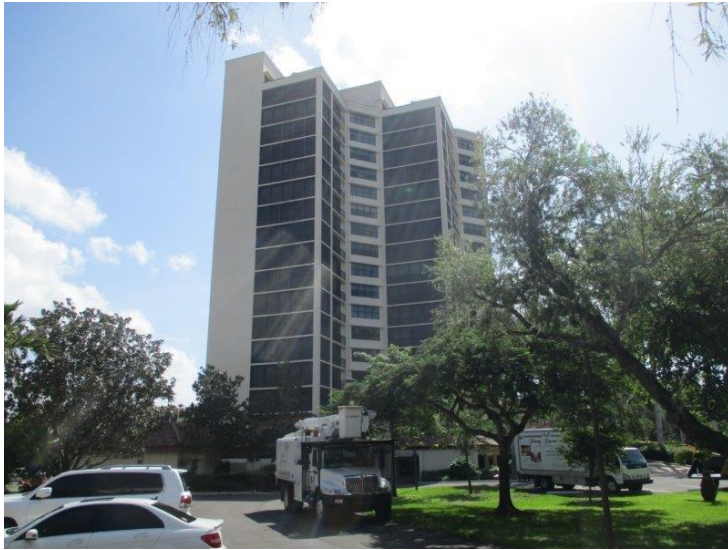
Exterior Elevation

- 1. Building Code:** **Unknown or does not meet the requirements of Answer A or B**
Comments: The year of construction was verified as 1986 per Collier County Property Appraiser.

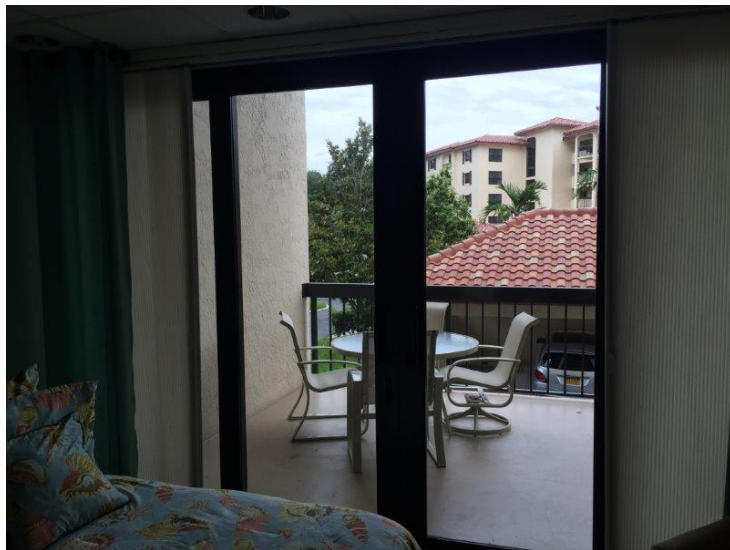
Opening Protection

- 7. Opening Protection:** **Exterior Openings Cyclic Pressure & 9-lb Large Missile**
Comments: Inspection verified all glazed openings are protected with Large Missile Impact rated windows and sliding glass doors. The entry doors are of original construction with no impact testing specifications.
