COMMERCIAL WINDSTORM MITIGATION REPORT (OIR-B1-1802)

Chateaumere Condominium Association, Inc.

6020 Pelican Bay Blvd, Bldg E, Units 101-405

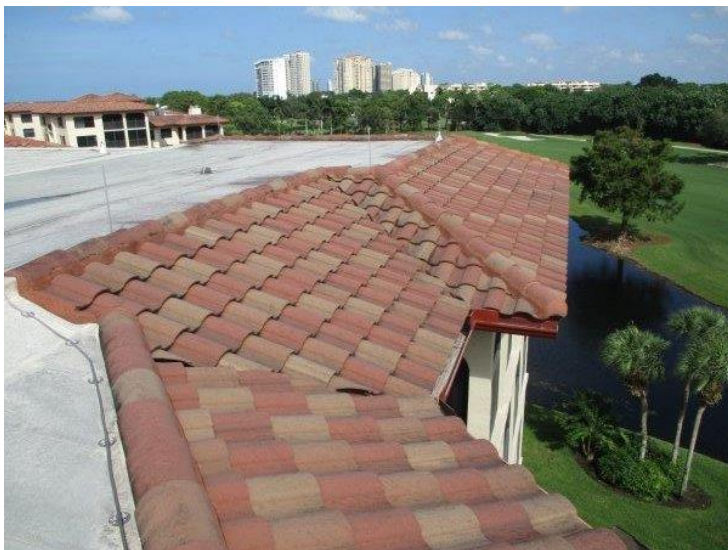
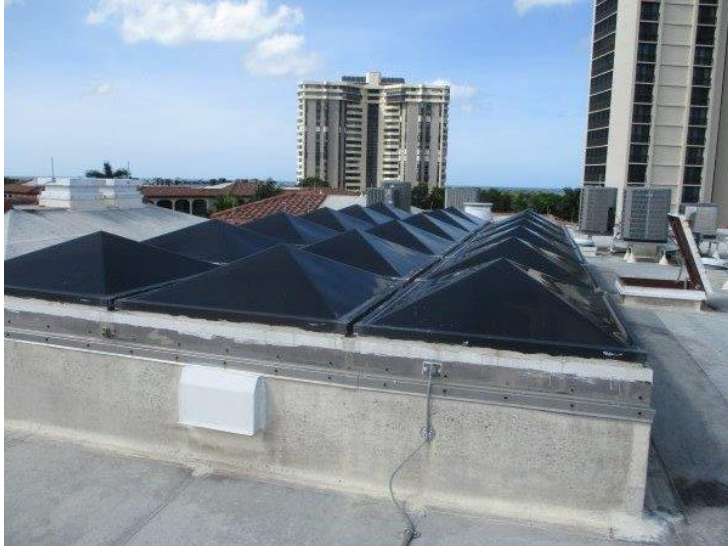
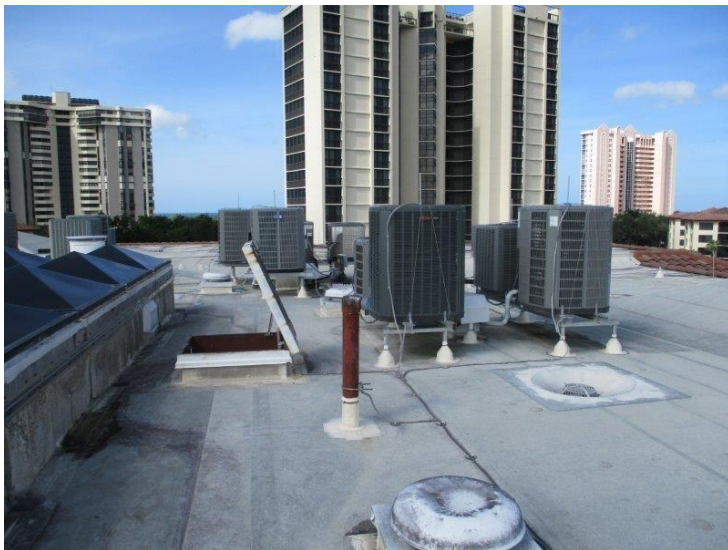
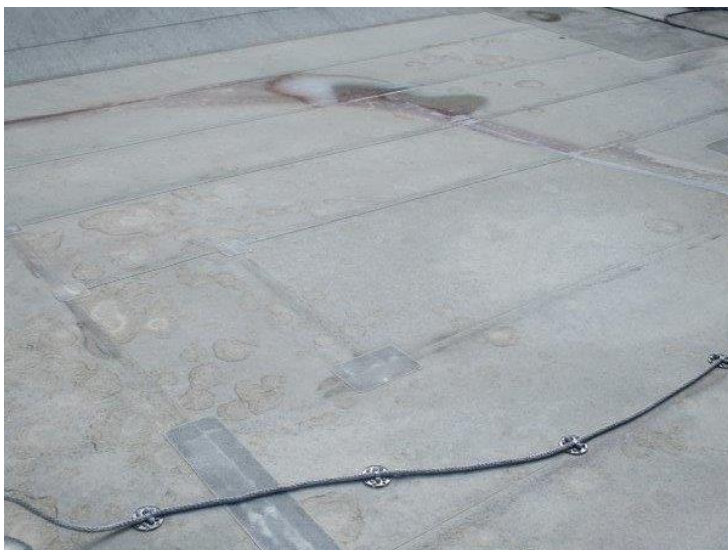
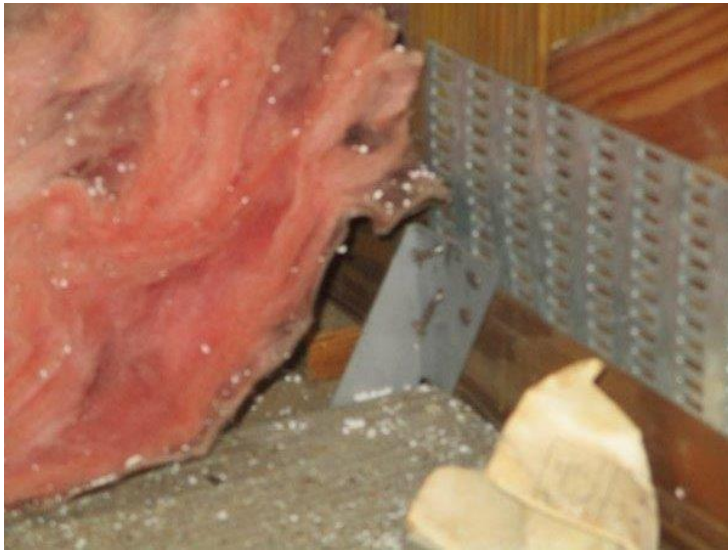
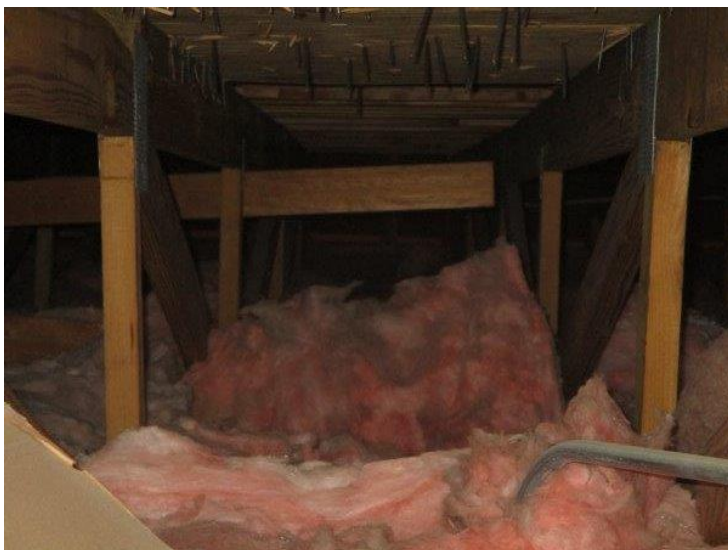
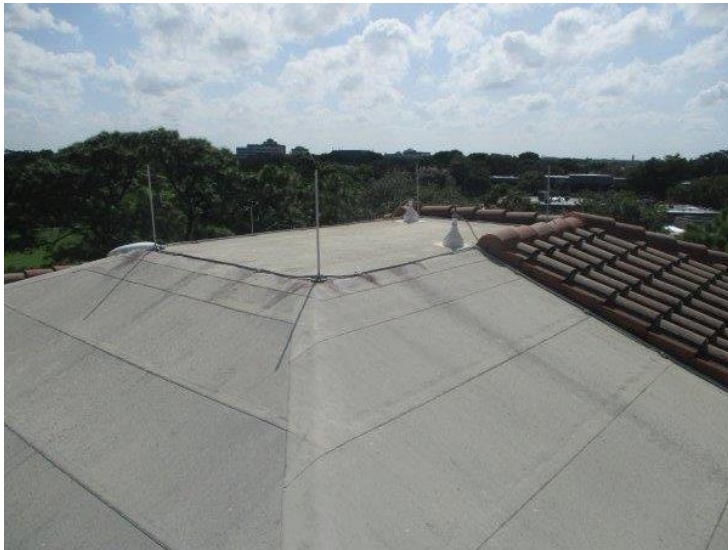
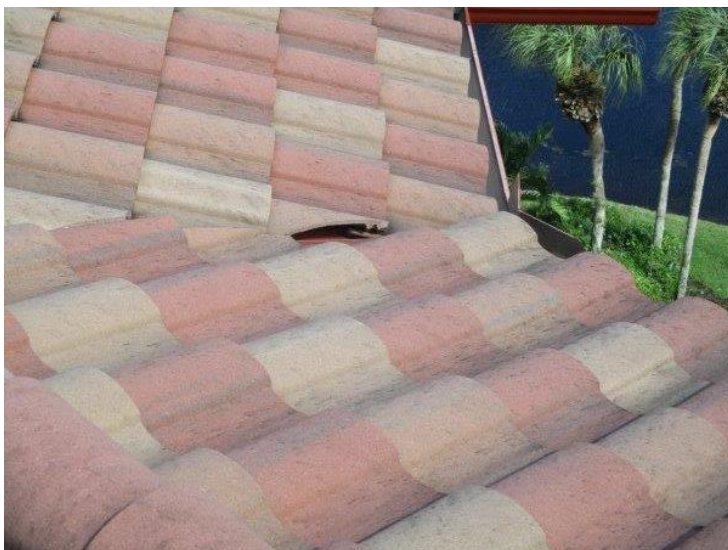
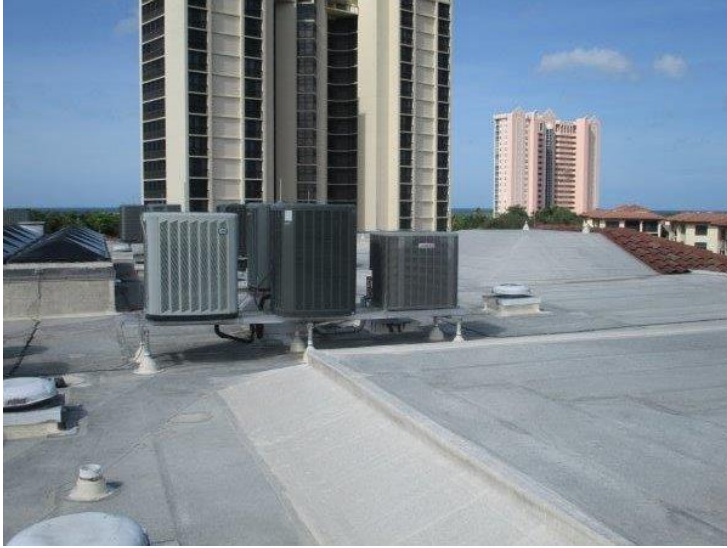
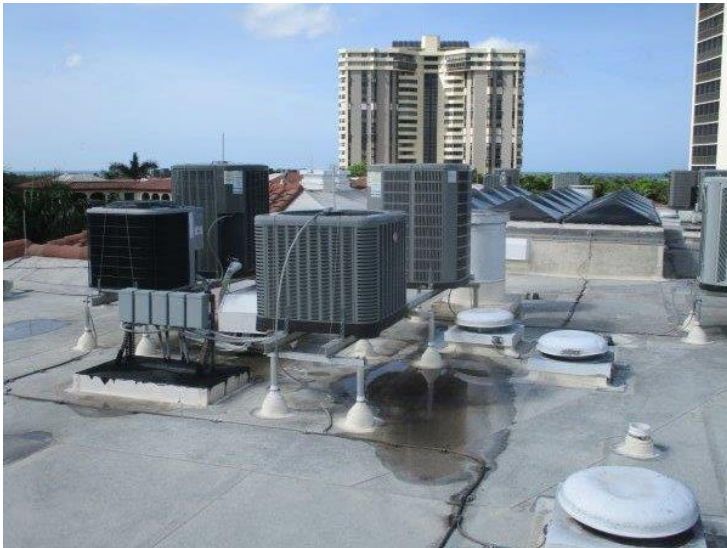
- 3. Roof Deck Attachment:** **Level B**
Comments: Inspection verified 1/2" plywood roof deck attached with 8d nails at a minimum of 6" on the edge & 12" in the field.

- 4. Roof to Wall Attachment:** **Clips**
Comments: Inspection verified hurricane clips fastened with a minimum of three nails.
- 5. Roof Geometry:** **Other Roof**
Comments: Inspection revealed a combination of pitched and flat roof areas. The flat roof area accounts for approximately 64% of the total roof area.

Roof Construction
